# Documentation of the performance gap

Søren Østergaard Jensen, Danish Technological Institute  
Kim Wittchen and Jørgen Rose, Danish Buildings Research Institute

## Two examples of documenting the performance gap

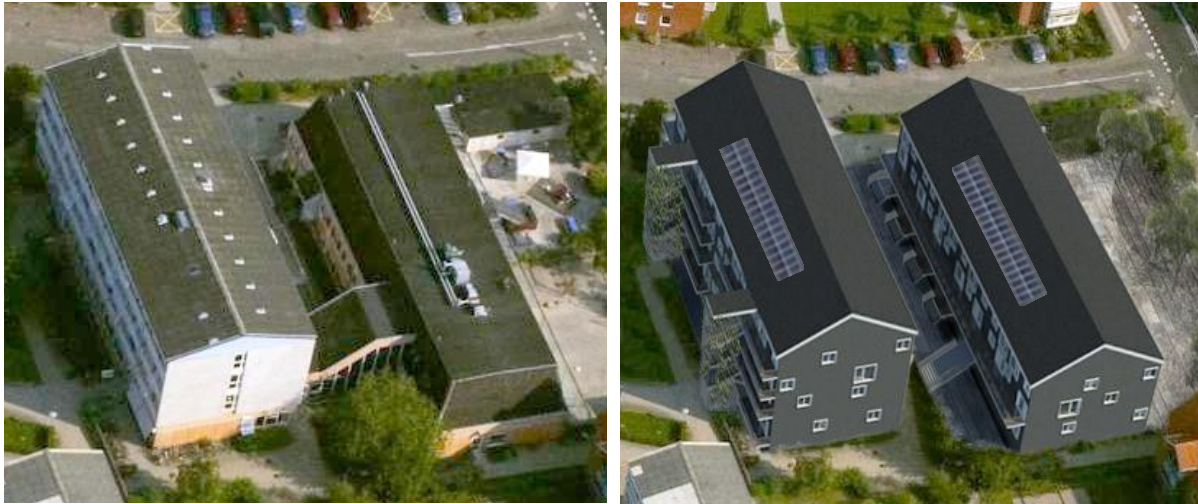
Sems Have was originally constructed in 1970-72 under the name “House of youth”. The two buildings were a four-story building with a dormitory at the first to fourth floor, and an activity centre for school-children at the ground floor. The other building contained a day-care centre for small children at the ground floor and two smaller concert halls at the first floor. In 2011 the buildings were totally worn down and the housing association had to decide if the buildings should be demolished or refurbished. Based on economical calculations it was decided to refurbish the buildings and turn them into 30 modern low energy apartments. Figure 1 shows the buildings before and after the renovation.

Figure 1. Sems Have/House of youth before (left) and after (right) the renovation. Not only the interior but also the exterior went through a major renovation.
