## Commissioning of HVAC systems in a campus building with regard to the indoor environment and energy performance

*Published in:*  
Proceedings of Building Simulation 2019

Chen Zhang, Adam Stoltenberg Iversen, Anda Senberga, Andras Cedl, Liena Krastina, Vilija Matuleviciute, Evangelia Loukou, Mingzhe Liu, Anna Joanna Marszal  
Department of Civil Engineering, Aalborg University, Aalborg 9200, Denmark

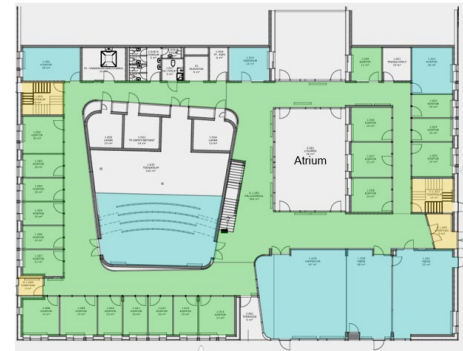
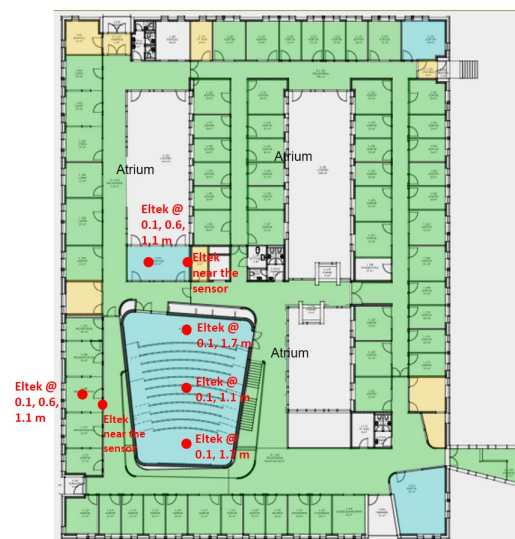
- - Room with temperature sensor, light sensor and damper
- - Room with temperature sensor, CO2 sensor and light sensor, VAV
- - Room with temperature sensor and light sensor
- - Room without control system

Figure 1: Building floor plan, control strategies and measured positions. (a) Ground floor; (b) First floor

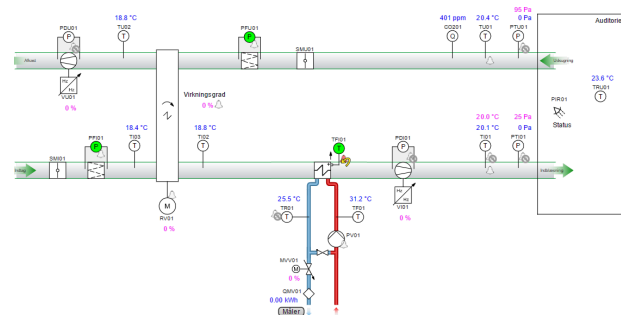
The building has three ventilation systems installed. VE01 and VE02 are centralized air handling units (AHU) located in the technical room. As shown in Figure 2, the supply section consists of on-off damper, filter, rotary heat exchanger, heating coil and supply air fan, in the end, there is a heating coil, while, the exhaust section consists of: exhaust fan, rotary heat exchanger, filter and on-off damper. VE01 is used to ventilate offices and meeting rooms, while VE02 is only used to ventilate auditorium. VU01-4 includes four exhaust systems, which extract polluted air from toilets. The supply air temperature of AHUs varies based on the outdoor temperature. There is no cooling system in this building, therefore, a night cooling function will be activated if the following conditions are fulfilled: Outdoor temperature is 3 °C lower than room temperature; room temperature is higher than 23 °C; outdoor temperature is higher than 10 °C; less than 5 hours to switch to daytime operation mode. Detail description of ventilation systems refer to Table 3

Figure 2: BMS interface of VE02 AHU system and the control system.

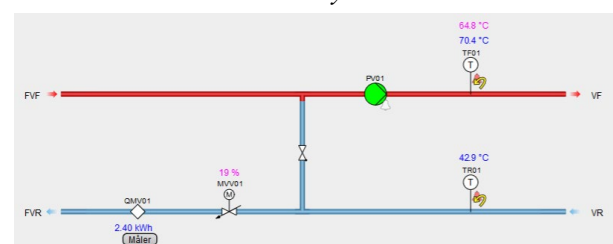
The heating system in the building is supplied from the district heating terminal. It is divided into two mixing loops, RA01 for the South/ West facing part of the building, and RA02 for the North/ East orientations, see Figure 3. The supply temperature is controlled by a time schedule that controls the set-points. The time schedule has two modes, day operation and night setback. The day operation is active between 04:00 and 22:00 after which the night setback is active. The day operation starts this soon because the system has to heat the rooms before the occupants show up. The temperature of the return water is controlled and kept below 50 °C, the highest value allowed by the BMS is 60 °C. If those limits are violated the alarm goes off and the pump is shut down.

Figure 3: BMS interface of RA01 heating loop and the control system.

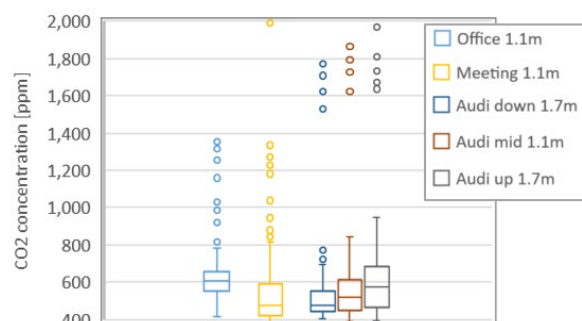
Figure 4 summarizes the monthly CO<sub>2</sub> concentration in the breathing zone in three rooms. The box presents 25%-75% of all measured values during the working hours. The average CO<sub>2</sub> level in office and meeting room are 620 ppm and 537 ppm. In the auditorium, the CO<sub>2</sub> are measured at three locations: lower zone, a middle zone, and an upper zone, where the CO<sub>2</sub> level is 608 ppm, 646 ppm and 700 ppm, respectively. The concentration stratification indicates the displacement effect. It can be noticed that CO<sub>2</sub> level exceeds 1000 ppm in all three rooms, although it exists in a very short period, which accounts for 4.1%, 3.6% and 6.3% of the total working hours in the office, meeting room and auditorium, respectively.

Figure 4: Monthly overview of CO<sub>2</sub> level in three rooms in the working hours.

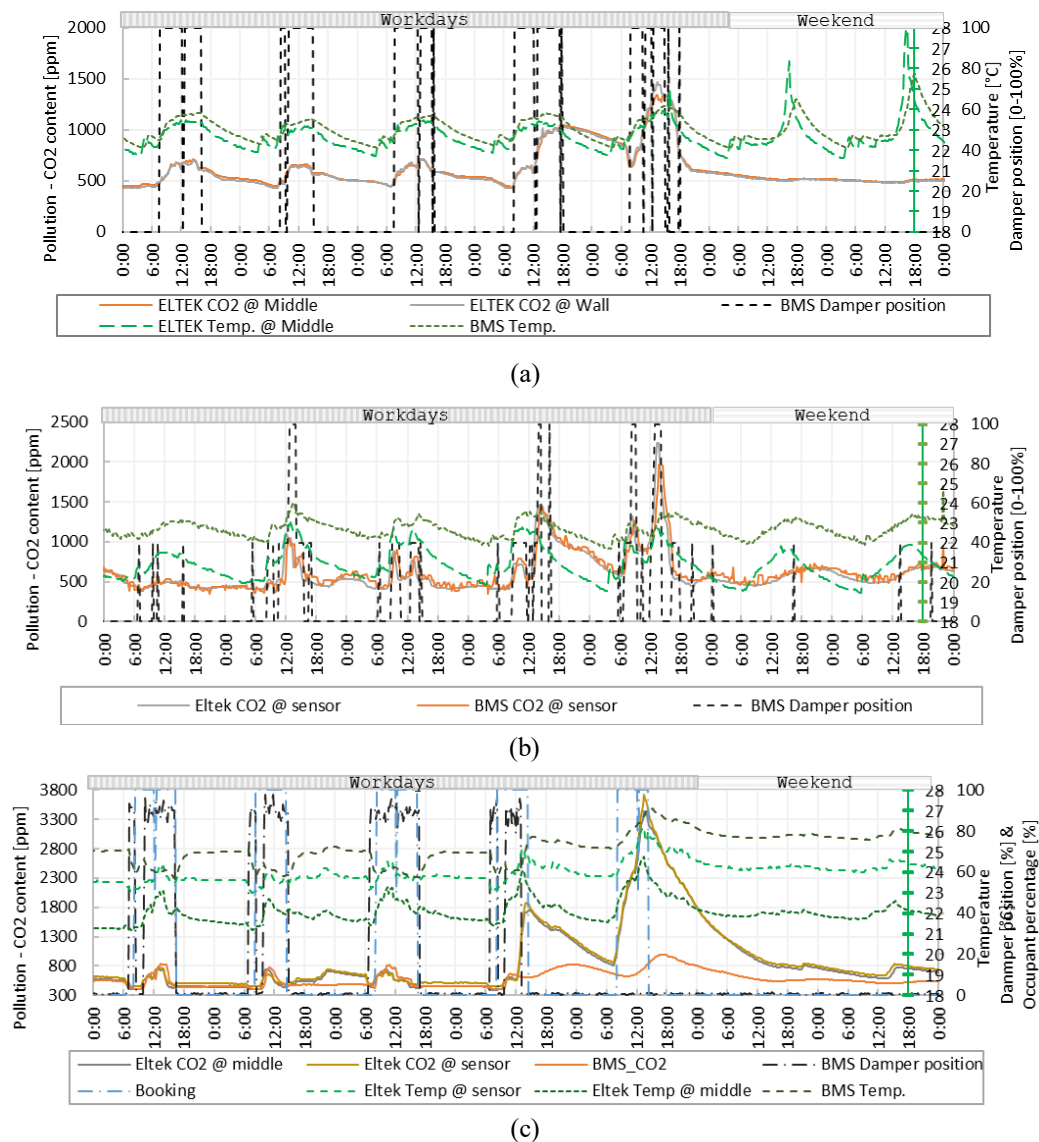
The damper position in relation to the indoor CO<sub>2</sub> level and temperature level in three different rooms is analyzed here, as illustrated in Figure 5. It is clear to see that damper only operates in on/off model in the office. The damper is controlled by occupancy monitored by PIR sensors, this is explained why the damper has a short turn off period during the lunch hour. There is no CO<sub>2</sub> sensor in the office. Eltek sensors measured the CO<sub>2</sub> level at two positions, which indicates a good mixing has been reached in the room. However, it also reveals that the constant flow rate is not able to handle the excess CO<sub>2</sub> level, where the CO<sub>2</sub> reaches approximately 1400 ppm in 16<sup>th</sup> March.

The damper in the meeting room can operate in three models: 0%, 40% and 100%. The damper will open to 40% when the PIR sensor detected the occupancy. The damper opening will increase to 100% when the CO<sub>2</sub> level exceeds the setpoint of 1000 ppm. However, even the damper operated at 100% opening, the CO<sub>2</sub> level still exceeded 1000 ppm in 15<sup>th</sup> and 16<sup>th</sup> March. In the weekend, the damper was activated in a short period might due to people enter the meeting room. Large deviation up to 2 °C was found between the temperature measured by Eltek and monitored by BMS sensor. The reason for the large deviation is because the BMS sensor is located next to a big screen, which releases heat and blocks the sensor.

The ventilation system in the auditorium is a VAV system, where the damper can operate from 0% to 100%. The damper opened 1 hour before the booking time and closed 30 min after the booking time. However, the damper closed 2 hours before the booking time finished in 15<sup>th</sup> March and didn't open in 16<sup>th</sup> March even though the auditorium was booked, which led to the CO<sub>2</sub> reached 3800 ppm in 16<sup>th</sup> March. In addition, the monitored data

indicates that damper either be off or operated around 90% opening in the observation period. The high damper opening level might due to the high indoor temperature monitored by BMS sensor. The ceiling height of the auditorium is 7.58 m, and the BMS sensor locates on a cabinet at the lower zone. The cabinet is used to store equipment, which has continue heat loads. Therefore, the indoor temperature monitored by the BMS sensor is above the setpoint all the time, which is generally 2 °C higher than the Eltek sensor located at the same height and 4 °C higher than the Eltek sensor located in the middle of the auditorium. Another deviation exists at the CO<sub>2</sub> level monitored at the exhaust duct by the BMS sensor and Eltek measured in the lower zone and the middle of the room. The ventilation system in the auditorium is a displacement system, where the exhaust CO<sub>2</sub> is expected to be higher than the one in the occupied zone. However, high CO<sub>2</sub> level up to 3800 ppm was measured in the occupied zone in 15<sup>th</sup> and 16<sup>th</sup> but the exhaust CO<sub>2</sub> was below 1000 ppm. This might be caused by the ventilation system didn't run in 16<sup>th</sup> March, so the polluted air was not extracted through the exhaust duct.

It is surprised to see that the high CO<sub>2</sub> level was observed in all three rooms in 15<sup>th</sup> and 16<sup>th</sup> March. It might due to the high outdoor CO<sub>2</sub> in these two days. However, due to the lack of monitor data on outdoor CO<sub>2</sub> level, we cannot make a solid conclusion.

Figure 5: Operation of ventilation system in three rooms (week 11: 12-18 March 2018) and the comparison of measured and monitored indoor environment. (a) Office; (b) Meeting room; (c) Auditorium

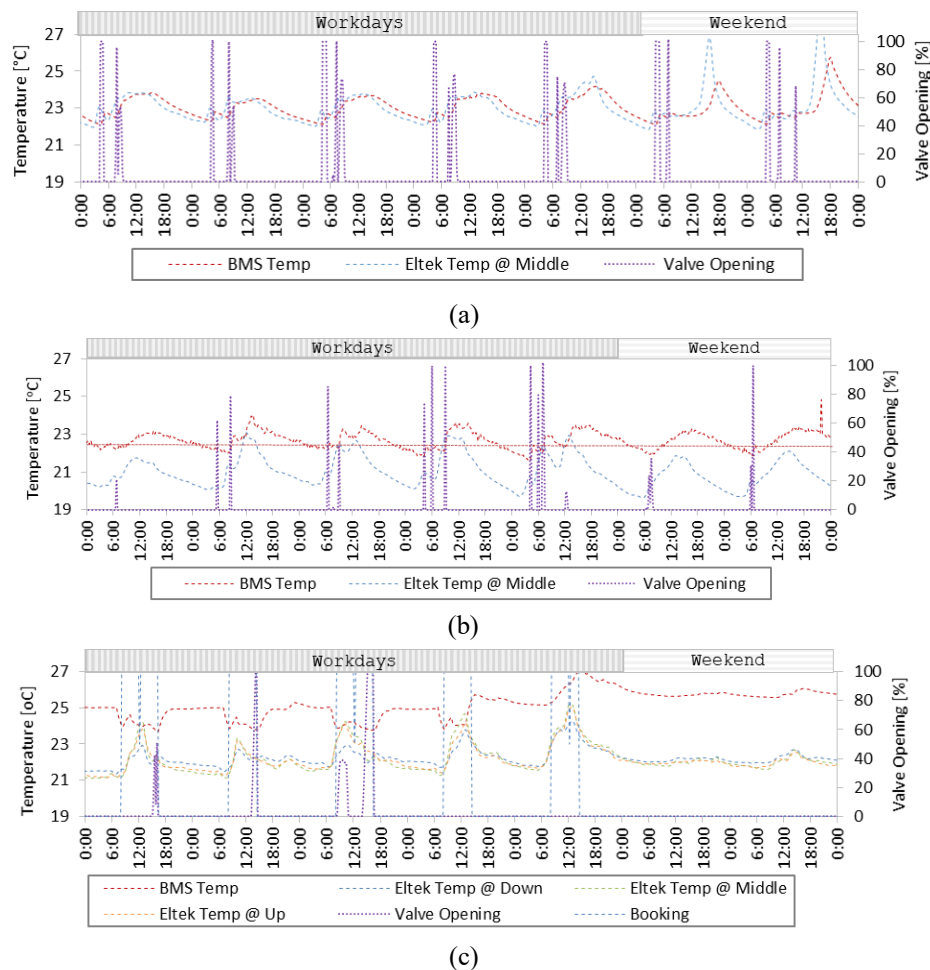
Figure 6: Operation of the heating system in three rooms (week 11: 12-18 March 2018) and the comparison of measured and monitored temperature. (a) Office; (b) Meeting room; (c) Auditorium

The operation of the heating system is analyzed in three rooms, as shown in Figure 6. The valve opening of radiators adjusts according to the temperature sensor connected to the BMS system. If the temperature is lower than set-point (shown in Table 2), the valve will be turned on.

In the office, the valve turns on at 4:00 am to preheat the room before occupants show up. It turns on again in the working hours if the temperature from BMS sensor is below the setpoint of 23 °C. The temperature in the occupied zone was measured by Eltek sensor at 1.1 m height and compared with the values from the BMS sensor. The deviation is less than 0.5 °C in the weekday but above 3 °C at the weekend. It is surprising to see that the radiator operates in the same way in the weekend, which results the indoor temperature is even higher in the weekend than the weekdays and it wastes of heating energy.

In the meeting room, the valve turns on between 4:00 am to 6:00 am to preheat the room. The valve turns on again in the working hours if the temperature monitored by the BMS sensor is below the setpoint of 22.5 °C. However, the large deviation is observed between the temperature in the occupied zone measured by ELtek with the BMS sensor located on the wall and the temperature difference is above 2 °C. Therefore, the indoor temperature in the occupied zone ranges from 20 °C to 23 °C in the working hours, and from the survey we observe many occupants complained about the low indoor temperature.

In the auditorium, the valve only activates during the booking time and BMS temperature is below the setpoint of 24 °C. However, due to the wrong location of BMS sensor as described in the section above, the actual indoor temperature in the occupied zone is much lower, especially in the first several hours the temperature is even below 21 °C.

2. Adjust heating schedule: As shown in Figure 6, the heating system run with the same setpoint in the weekend in the office and meeting room. It suggests lowering the setpoint in the weekend to 20 °C (meeting and office).

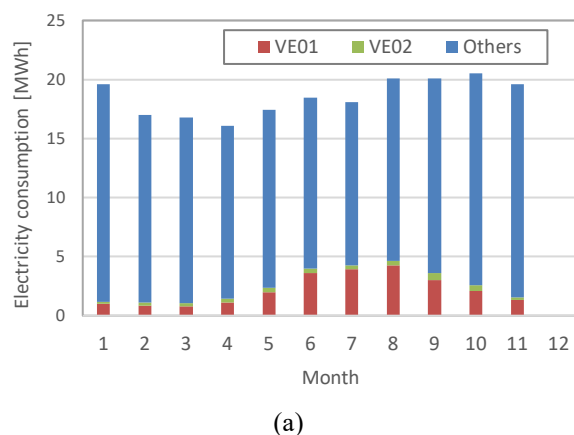
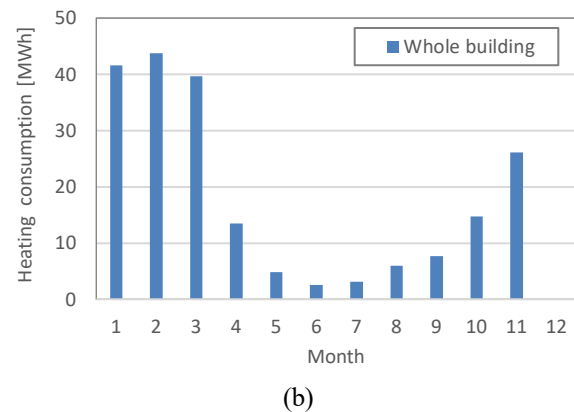
Figure 7 shows the building energy consumption from Jan to Nov 2018 in term of electricity and heating. The main consumers of electricity in the building include ventilation systems, lighting, appliances and auxiliary equipment. There is no detail data available on the lighting and applications consumptions, therefore, we divide it into ventilation systems and the others. There is no large variation in electricity consumption during the whole year, where the average monthly consumption is 17 MWh. However, a clear seasonal variation on the electricity consumed by ventilation systems can be seen in Figure 7 (a). It accounts for up to 23% of total electricity consumption during the summer season and reduces to 6% in the winter season. The high electricity usage in summer is because ventilation is used to prevent overheating and the ventilation flow rate is much higher than the one used for maintaining the CO<sub>2</sub> level. On the other hand, the lower artificial lighting usage in summer results in no large difference in the overall electricity consumption during the year. The heating consumption is shown in Figure 7 (b), which cover space heating, domestic hot water and heat coil in the ventilation systems. Heating demand has a remarkable seasonal variation, which is about 2.5 MWh in June and 43.8 MWh in February. Due to the lack of data in Dec, the total heating demand in 2018 until Nov is 203.4 MWh and the value for electricity is 203.8 MWh.

Figure 7: Building energy consumption 2018 (Data in December is not available). (a) Electricity (b) Heating

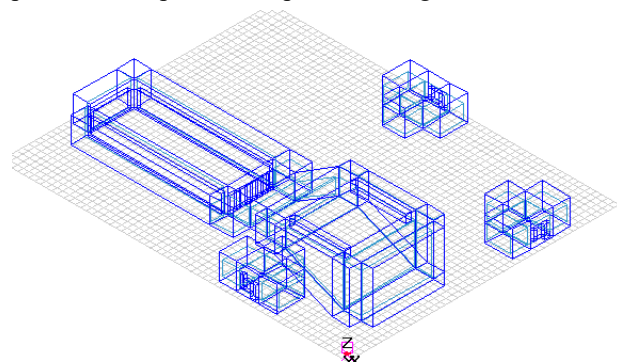
A dynamic model is developed in BSim to analyze the building performance in term of indoor environment and energy use, and further use to investigate the impact of several optimization strategies on the overall energy performance. Three rooms (office, meeting room and auditorium) are chosen for the simulation to represent the whole building, as shown in Figure 8. The weather file is developed based on the data logged by the weather station near the case building. Each room is represented by a thermal zone which is able to have individual input on the people and equipment load, time schedule and controls for HVAC system. The input values are defined according to the measured data or the monitored data from BMS in order to represent the building system and operation characteristics to a large extent. However, there several uncertain parameters might lead to the deviation between model and real building performance. For example, the real occupant number and occupied hour might differ from the design values; lack of information on lighting and appliance usage; the model assumes a good mixing in the room lead to a uniform temperature and CO<sub>2</sub> level in all positions, etc. To calibrate the model, an iterative process takes place, as explained in Figure 9.

Figure 8: BSim model for case building.

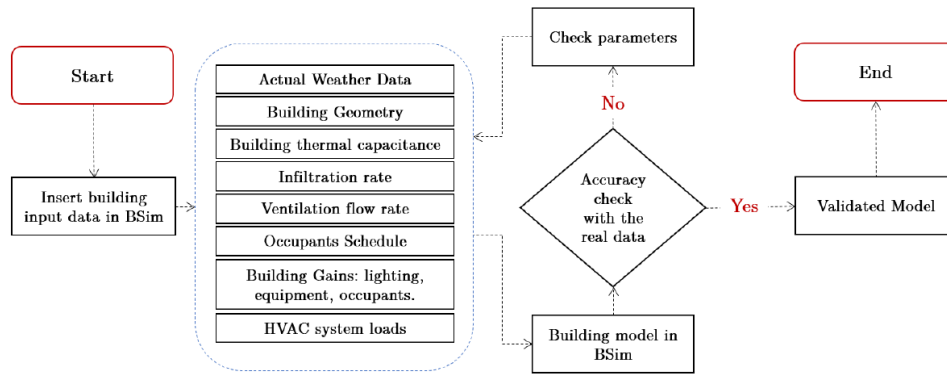
Figure 9: Model calibration process.

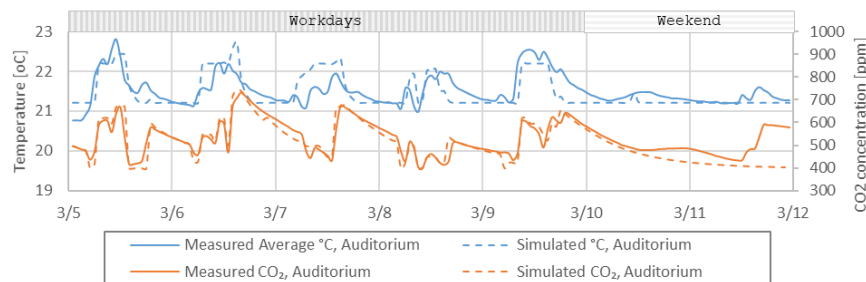
In order to validate the model, the correlation between the on-site measured and simulated temperature and CO<sub>2</sub> level are investigated in three rooms. As an example, Figure 10 shows the results in the auditorium in week 10. It is clear to see a good agreement has been reached between the measured and simulated values. The temperature deviation is less than 1 °C in the whole week

Figure 10: Measured and simulated temperature and CO2 level in the auditorium (Week 10, 5-11 March 2018).

with mean absolute percentage error (MAPE) of 1.12%. The CO<sub>2</sub> values correspond well in the weekday, a large deviation of approximately 200 ppm occurs in the weekend, due to the unexpected occupancy. The MAPE of CO<sub>2</sub> is 5.87% during the whole validation period. Because the detail energy consumption in the room level is not available, no comparison between the monitored value and simulated value presents here. The accuracy of the model is acceptable and will further use to simulate optimization strategies.

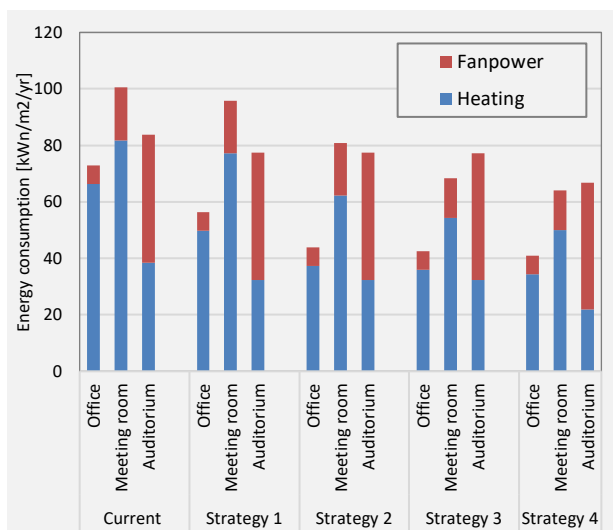
Figure 11 summarizes the energy saving potentials by implementing different optimization strategies. It needs to notice only heating demand (space heating and heating coil) and fan power are analyzed here, due to the limitation of the numerical model and lack of detail information on the electricity consumption on other components. As expected, strategy 1 and strategy 2 have a significant impact on the space heating demand in all three rooms, especially in the office the space heating demand decrease from 62 kWh/m<sup>2</sup>.yr to 34 kWh/m<sup>2</sup>.yr, which reduce 45% heating demand. Strategy 3 has a marginal impact on the energy consumption of the fan. It reduces from 19 kWh/m<sup>2</sup>.yr to 14 kWh/m<sup>2</sup>.yr in the meeting room and from 46 kWh/m<sup>2</sup>.yr to 44 kWh/m<sup>2</sup>.yr in the auditorium. The small impact is because no significant overheating exist in both rooms during summer. The last optimization strategy increases the heat recovery efficiency in the ventilation system and effectively reduce the heating need in the heating coil, therefore, the heating demand further decrease in three rooms. By implementing all the optimization strategies,

the energy saving potential in the office, meeting room and auditorium are 44%, 39%, and 20%, respectively. The indoor environment in term of operative temperature and CO<sub>2</sub> level are checked in each scenario and it is validated that energy saving strategies do not sacrifice the indoor environment.

Figure 11: Energy consumption on heating and fan power in three rooms in current condition and optimization strategies.

1. Adjust heating setpoint: The existing control system indicate that the temperature setpoint for heating and cooling (ventilation) has the same value in office and auditorium, which results in unnecessary energy consumption on heating and ventilation systems to maintain constant indoor temperature. On the other hand, the setpoint temperature for heating is too high and it is suggested to reduce the value to 22 °C in all the rooms.

3. Adjust ventilation setpoint: The function of the ventilation system is both provide acceptable indoor air quality (controlled by CO<sub>2</sub> sensor) and avoid overheating (controlled by a temperature sensor). The setpoint for CO<sub>2</sub> is based on EN15251 Category

ii that less than 500 ppm above outdoor level. However, the comfort temperature in summer season is 23-26 °C. The setpoint temperature for ventilation (cooling) set up as the lowest valve, which leads to unnecessary energy waste. It suggests increasing the setpoint for ventilation to 25 °C in the meeting room and auditorium.

4. Increase heat recovery efficiency: The monitor data shows the heat exchangers do not achieve the optimal efficiency as required in the BR15. It is interesting to find out how much energy could be saved by increasing the heat recovery efficiency to even 85% (class 2020).
