Published in:
12th Nordic Symposium on Building Physics (NSB 2020)

Towards moisture safe ventilated cold attics – Monitored conditions in a full-scale test building

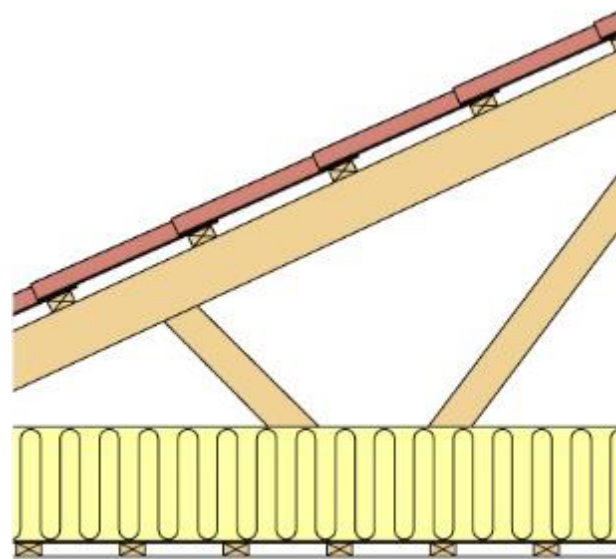
Fig. 1. Cross section of a typical construction with ventilated cold attic space. Ventilation of the attic space is ensured with necessary openings in the eaves and in the top. Air tightness of the ceiling construction is ensured by either vapour barrier below the insulation or by an airtight ceiling. From [1].

Roof construction with ventilated cold attic has traditionally been good building practice in many countries including the Nordic countries, see Fig. 1 for a cross section of a typical attic construction. A combination of the sloped, watertight roofing and a load bearing structure of timber has been widely used in both small and larger buildings. From the moisture safety point of view the sloped roofing has ensured protection of the building from rain loads while the ventilated attic has ensured necessary removal of any excess moisture from the interior environment to the attic space. Transport of the moisture from the living space to the attic space has been controlled by ensuring that the ceiling construction was airtight. Traditionally the airtightness of the ceiling has been ensured by a plastered ceiling without cracks. Vapour barrier was introduced in this type of constructions in the 1960's and was expected to ensure air and vapour tightness of the construction [2]. However, limited focus was paid on the sealing of the connections and details, and in practice the vapour barriers were not as tight as they nominally should.

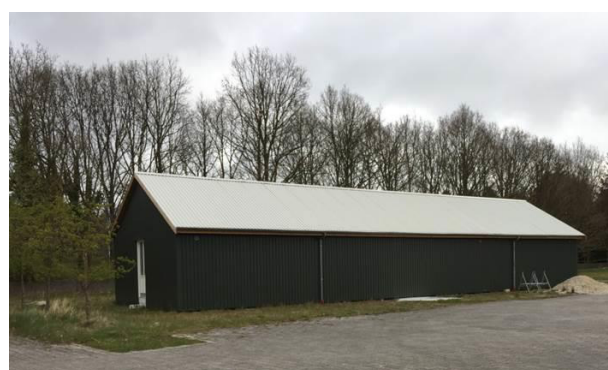
Fig. 2. South facade of the full-scale test house.

A full-scale test building with six different designs of attics was constructed (see Fig. 2 and 3) and equipped with temperature and moisture sensors (see Fig. 4). The house is located in the outskirts of Copenhagen, Denmark. Each of the six designs were exposed to three different humidity classes (HC) according to [7], in total 18 different attic cases were studied. The building has ground dimensions of 7 x 22 m and height of 4.6 m from ground to top of the roof. The pitched roof has a slope of 30 degrees and is oriented both South and North. Adequate ventilation of the attic was ensured by following the design rules in the Danish guidelines [2], in this case 2 x 50 cm² openings per metre at ridge, and effective opening area of 15 x 440 mm/m corresponding to 132 cm²/m at the two eaves. The air change rate per hour (ACH) was measured with passive tracer gas during several periods to 4 – 10 h⁻¹, which corresponds to values found in other studies, e.g. [8].

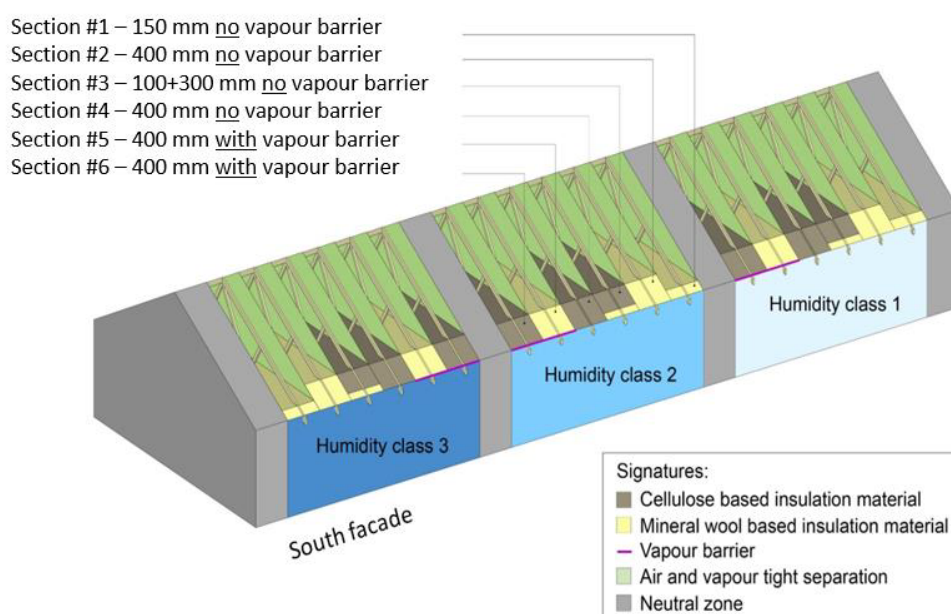
Fig. 3. Full-scale test house with 6 different attic designs with varying insulation type and thickness, presence of vapour barrier or not, and 3 different humidity classes of the indoor environment. Figure from [6].

For reliable analysis of the performance of the attics, every attic space was built to be independent on the hygrothermal conditions of the adjacent attic spaces. Air and vapour tightness was ensured by construction of vertical walls of plywood between every attic space and sealing these with vapour barrier and tape against each other. In the end of every series of attics, a dummy guard zone was established.

Ceiling construction against the indoor environment was airtight, as well, and finished with gypsum boards with airtight sealing of joints between boards. In attics with vapour barrier, a standard PE foil with $s_d = 140 \text{ m}$ was used. Loose fill mineral wool and cellulose was used as insulation material.

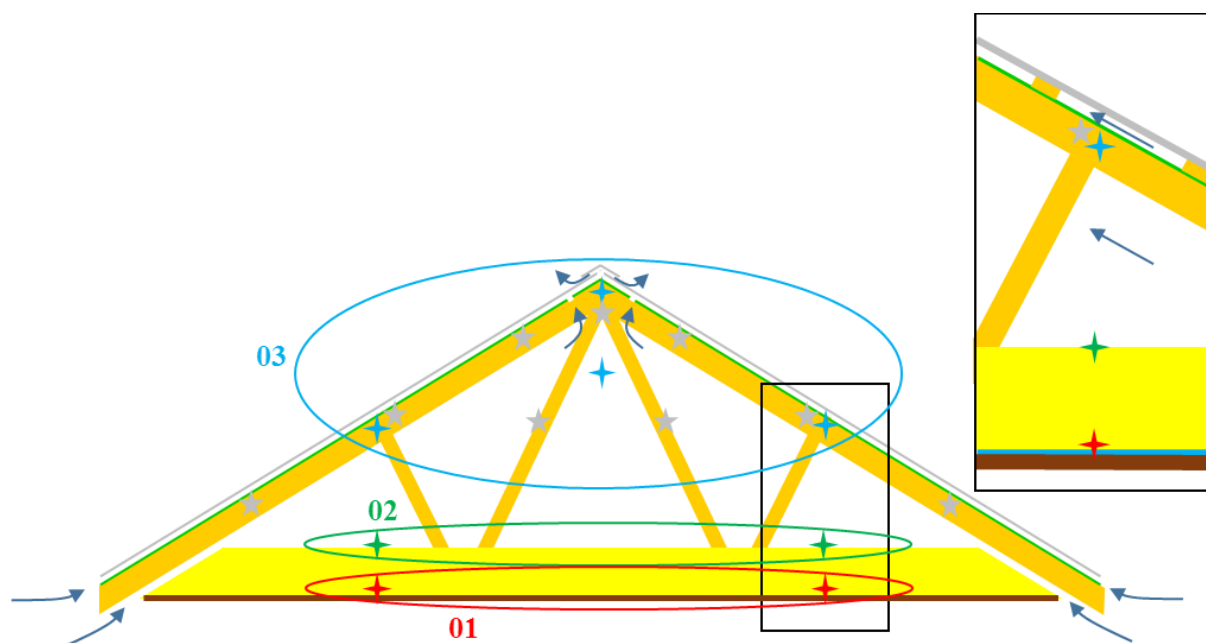
Fig. 4. Overview of the sensor positions. Grey stars denote wood moisture measurements while coloured stars represent temperature and relative humidity sensors. 01= sensors located below the insulation. 02= sensors located above the insulation. 03= sensors located in the attic space. Figure from [6].

Wood moisture content measurements were based on measurement of the electric resistance of wood as a function of moisture content. For that purpose, two 15 mm screws were mounted in the timber roof trusses for every sensor location described in Fig. 4 (seven in each attic section, 126 in total). The resistance was manually read every 7-14 days and converted to moisture content.

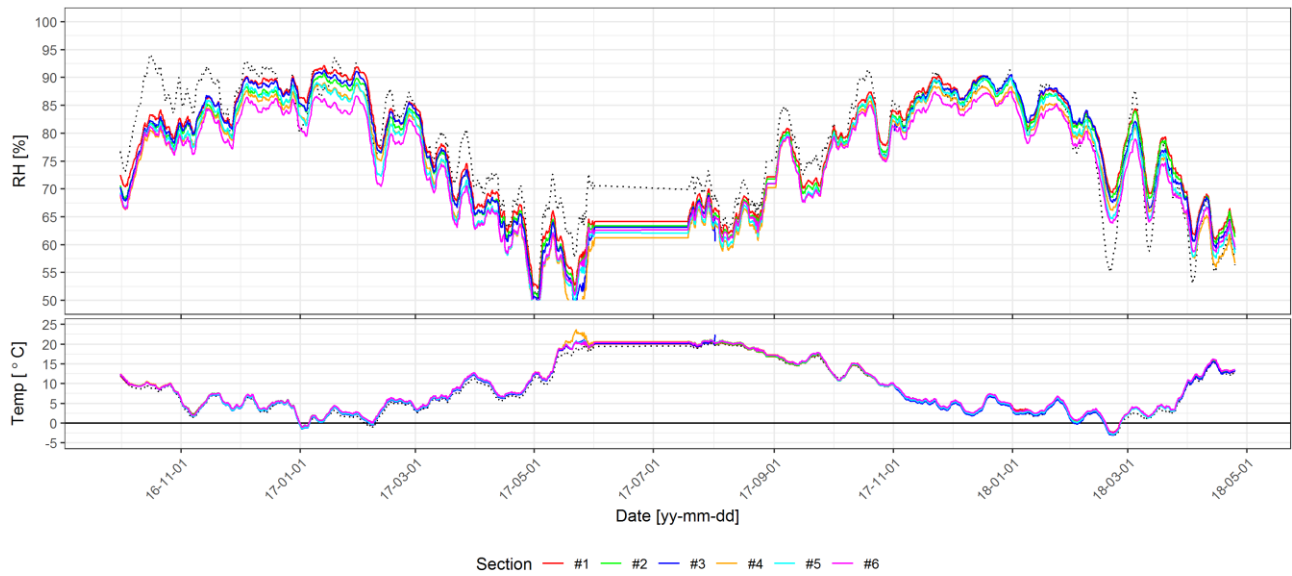
Fig. 5. Relative humidity and temperature in the attic space for attics #1 - #6 above humidity class 2. Average values for sensor position 03 (one week running mean). Black dotted lines describe outdoor relative humidity and temperature. Lack of measurements in the summer of 2017 was because the test house was moved to a different location and measurements therefore interrupted.

Monitoring results cover a period with more than two years. An overview of the measured conditions in the attics is seen in Fig. 5 that presents temperature and relative humidity for all attics in humidity class 2. Results are average values for sensor position 03 and one week running mean values.

Results show that the temperature is the same – and practically identical with the outdoor temperature – in all six attic spaces, including space #1 where there was only 150 mm insulation material while all the other spaces had 400 mm insulation material. In the first winter the relative humidity varied approximately within 10% RH between the different spaces, generally with lowest values in spaces with vapour barrier (#5 and #6), the difference was reducing to approximately 5% RH the second winter. This difference is probably due to build in moisture; the building was closed in November and heated from December, apparently, the attic was not totally dried out until after the first summer.

Although results according to Fig. 5 seem to prove the benefit of vapour barriers, the picture was not equally clear in other humidity classes, and as described in [6], there was no statistical evidence that vapour barriers reduced the relative humidity in airtight attics.

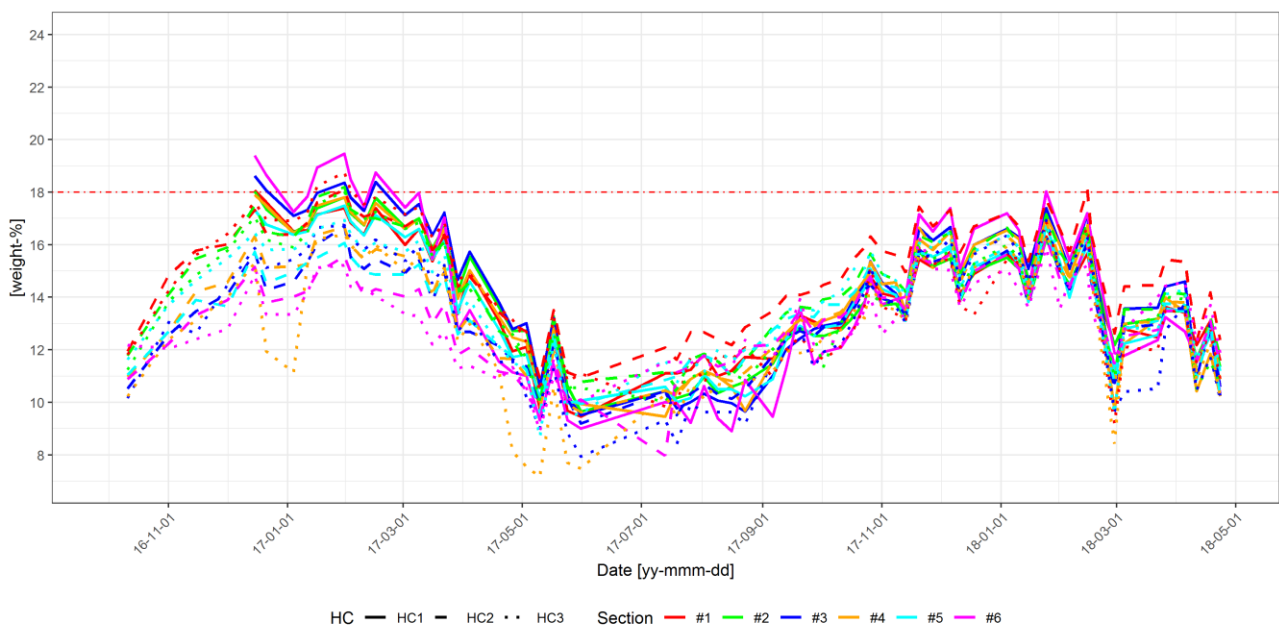
Fig. 6. Wood moisture content. Average for North side. Comparison of all attics. The test house section with HC1 was built one year later than the first two sections, hence the missing values for HC1 the first year.

An overview of the wood moisture content in all attics is seen in Fig. 6. Results are an average of the measurements from the north side of the attic and represent the worst case. Corresponding values from the South side are 1-3 weight-% lower.

After the first winter with built-in moisture, these results show that moisture content is not critical in any of the attics as moisture content stays below 18 weight-%, which represents a common limit for mould growth risk in wooden constructions (here spruce), corresponding to relative humidity of 80-85% and temperature around 10°C.

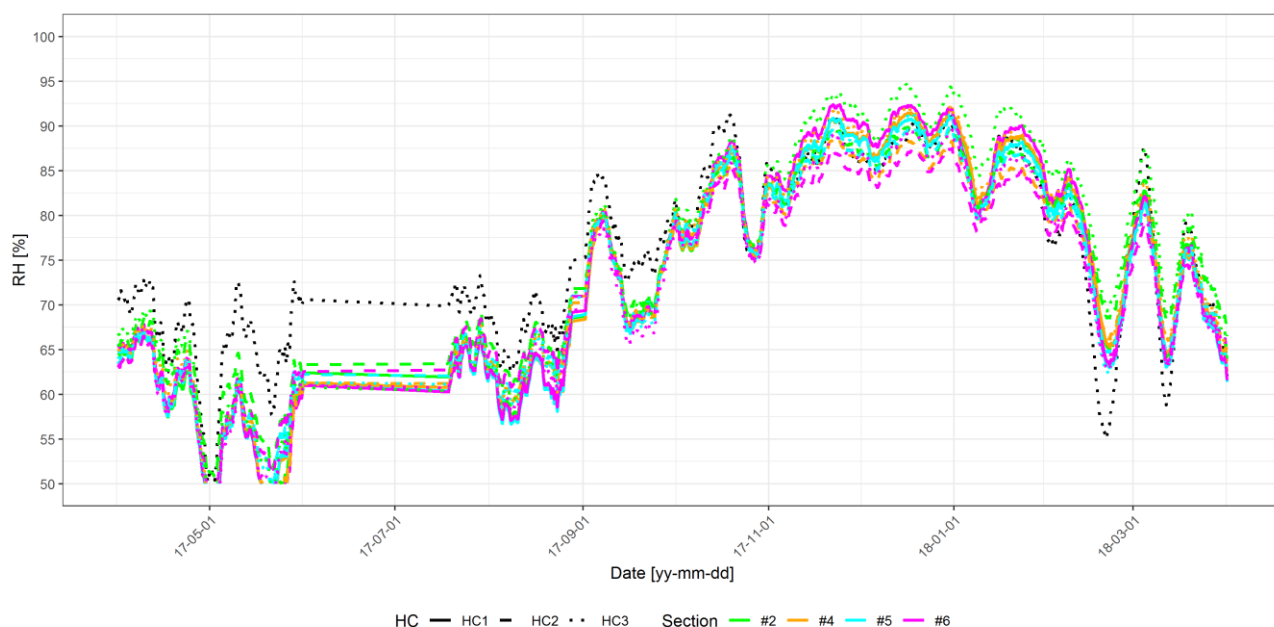
Fig. 7. Relative humidity in the attic space for attics #2, #4, #5 and #6 in all humidity classes (HC). Average values for sensor position 03 during the last year of measurements. Black dotted line describes outdoor relative humidity.

Fig. 7 shows relative humidity measurements for attics #2, #4, #5 and #6 during the last year. These values are an average of measurements in the attic space, i.e. sensor position 03 according to Fig. 4. This figure illustrates differences between insulation materials and the influence of vapour barrier as well as the role of humidity class.

Results show very little differences in relative humidity and no clear picture, as the order of sections with highest relative humidity is not the same in all humidity classes, e.g. in HC1 #6 has the highest relative humidity but in HC2 it has the lowest. Furthermore, many of the curves are so close together, it is difficult to distinguish them from each other. Statistical analyses made in [6] showed no statistical significant difference between spaces with or without vapour barrier or between the different insulation materials.

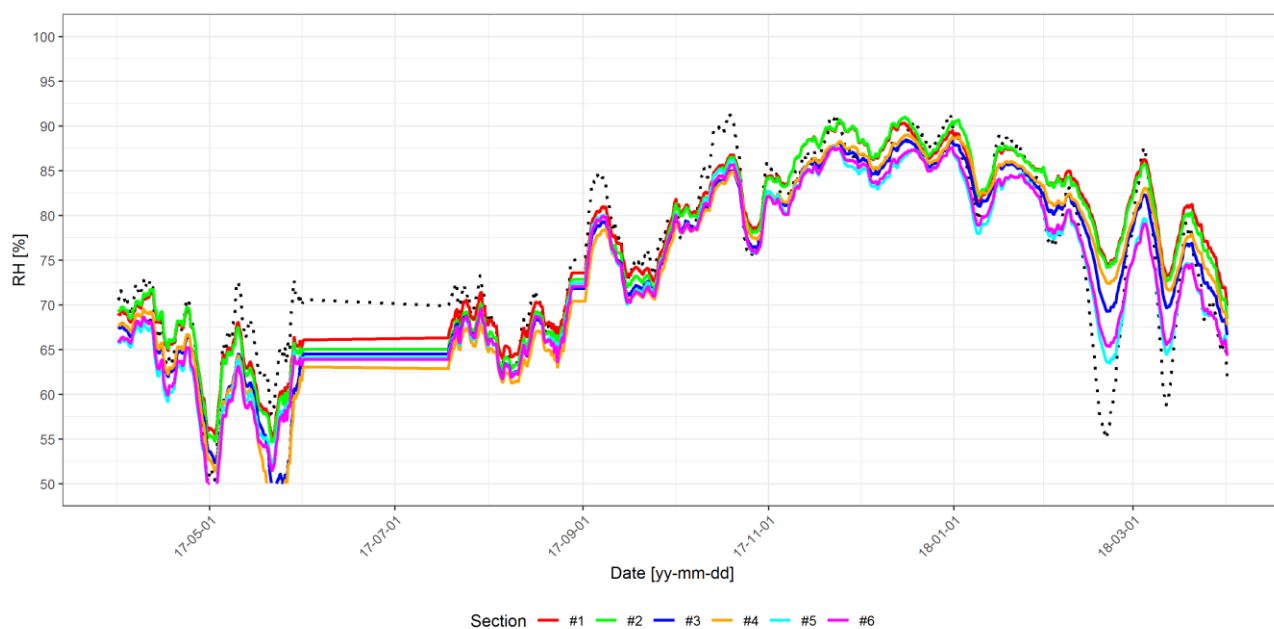
Fig. 8. Relative humidity in the attic space for attics #2, #4, #5 and #6 in humidity class 2. Average values for sensor position 02 (above insulation) during the last year of measurements. Black dotted line describes outdoor relative humidity.

Fig. 8 shows measured relative humidity in top of the insulation layer in sensor position 02. By comparing

Fig. 5 and 8, it is clear that the relative humidity in attics with vapour barrier was almost the same just above insulation as higher up in the attic space, while the relative humidity in attics without vapour barrier increased just above the insulation layer. While the hygroscopic insulation material seemed to reduce the relative humidity in position 02 if there was no vapour barrier (#4 compared to #2) the opposite was seen when there was a vapour barrier (#5 compared to #6). However, the differences were small and probably not statistically significant.

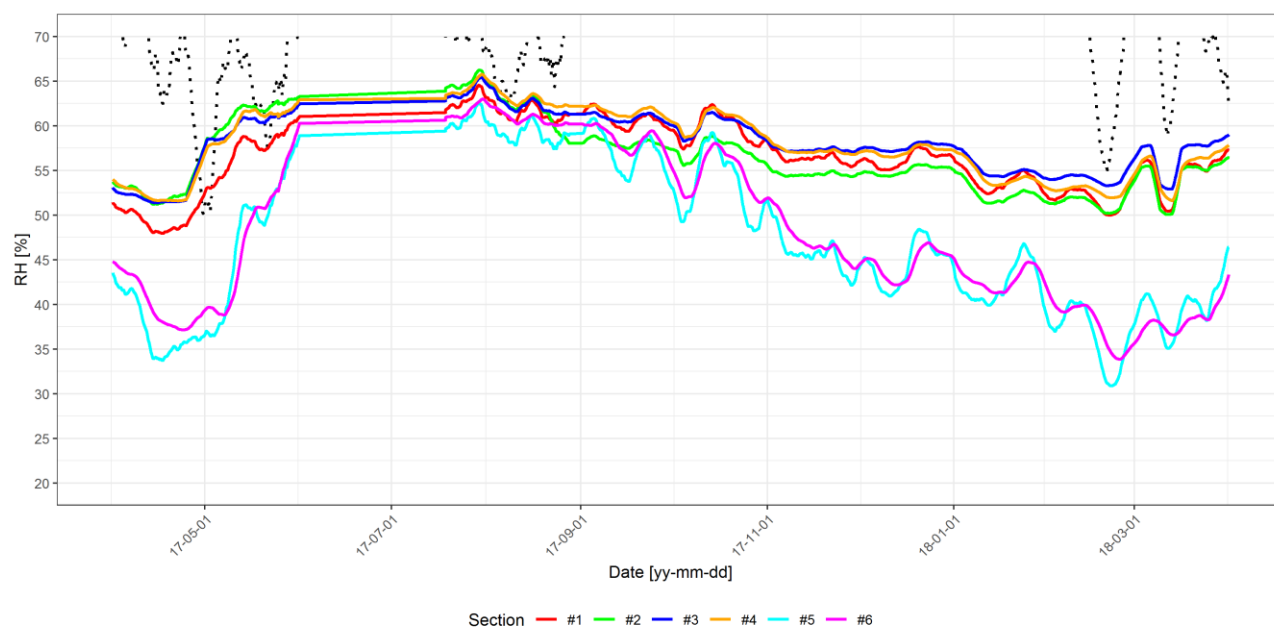
Fig. 9. Relative humidity in the attic space for attics #2, #4, #5 and #6 in humidity class 2. Average values for sensor position 01 (below insulation) during the last year of measurements. Black dotted line describes outdoor relative humidity.

Fig. 9 shows the relative humidity just below the insulation material i.e. position 01 in Fig. 4.

Here the difference between having a vapour barrier or not was very clear, as the relative humidity in this position for attics with vapour barrier (#5 and #6) is much lower than for those without vapour barrier. In attics with vapour barrier the relative humidity below the insulation material is independent of the moisture buffering capacity of the insulation material. Contrary, in attics without vapour barrier, the higher buffering capacity of cellulose (#4) increases the relative humidity compared to the comparable attic with mineral wool (#2). However, the relative humidity is very low in all cases, and there is therefore no risk of mould growth below the insulation in any of these cases.
