## Strength and Deformation Properties of Tertiary Clay at Moesgaard Museum

Kaufmann, K. L., Nielsen, B. N., & Augustesen, A. H. (2010). *Strength and Deformation Properties of Tertiary Clay at Moesgaard Museum*. Aalborg: Department of Civil Engineering, Aalborg University. DCE Technical reports, No. 103

**DCE Technical Report No. 103**

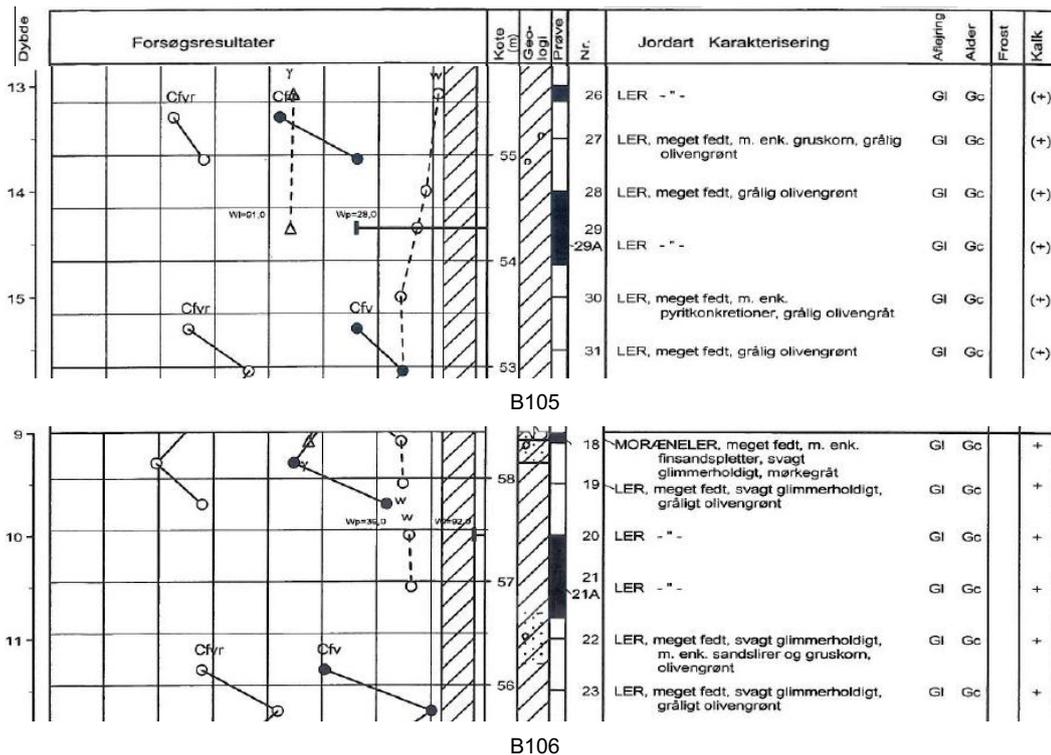
Figure 4: Segments of boring records B105 and B106 in depths of the soil specimens (29 and 21, respectively).

nection with the laboratory tests. Boring B106 is more sandy than boring B105. Segments of the boring records in the depths of the soil specimens can be seen in Fig. 4.

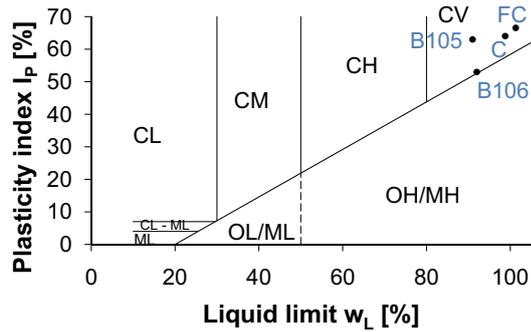
**Figure 5:** Classification of the tertiary clay at Moesgaard Museum according to the Casagrande Chart. *FC* is fall cone and *C* is Casagrande. According to Krebs Ovesen et al. (2007, Fig. 1.13).

The results of the Casagrande method and the fall cone method differ about 2–9 %, cf. Fig. 5.

The liquid limit and the plasticity index determined by the two boring records and the mean values of the laboratory tests are plotted according to the Casagrande Chart, cf. Fig. 5.

Hence, the clay is characterised as very high plasticity clay marked by *CV* in the figure in accordance to the geological description of the boring records. For comparison, the classification of Søvind Marl and Little Belt Clay are plotted in Fig. 6 together with the tertiary clay at Moesgaard (Johannesen et al., 2008; Thøgersen, 2001).

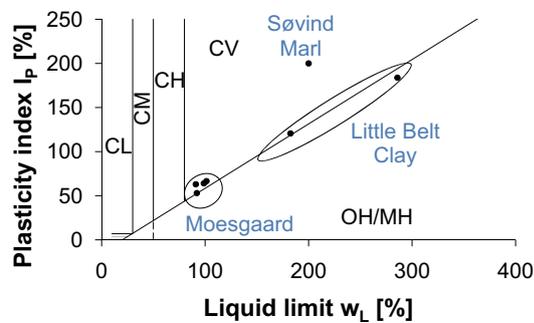
**Figure 6:** Classification of Søvind Marl, Little Belt Clay and the tertiary clay at Moesgaard Museum according to the Casagrande Chart. According to Krebs Ovesen et al. (2007, Fig. 1.13).

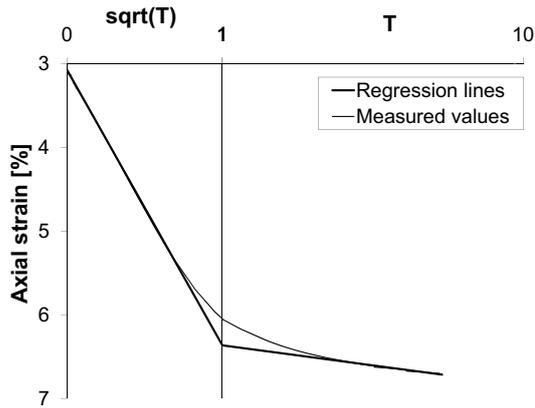
**Figure 7:** Strain–time curve for load step 6.  $T = 1$  is after about 0.5 day and the final  $T$  is after two days.

To ensure that secondary consolidation has occurred, the duration of each load step is two–three days depending on the progress of the strain–time curve. For example, the strain–time curve for load step 6, which is an increase of the loading from 600 kPa to 1200 kPa, can be seen in Fig. 7. The duration of the load step is two days by which the progress of the secondary consolidation can be described by a linear regression line.

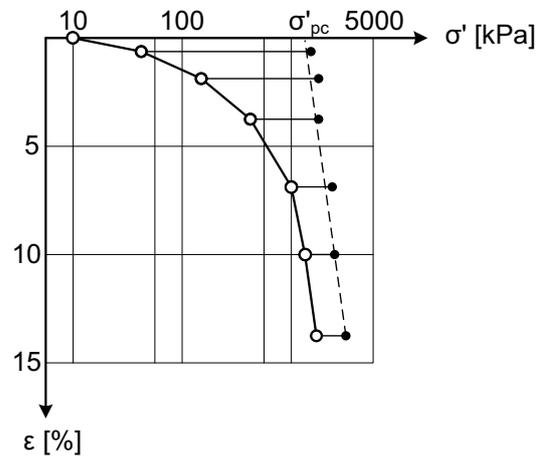
**Figure 8:** Determination of the virgin curve (the dashed line) used for Terzaghi's method.

Where  $C_{c\varepsilon}$  is the compression index,  $\sigma'_k$  is a reference stress and  $\varepsilon_0$  is the start value of the consolidation strain (not equal to the initial strain  $\varepsilon_i$ ). The reference stress  $\sigma'_k$  is the addition to  $\sigma'$  by which the primary path gets linear in a semi-logarithmic depiction, named the virgin curve, cf. Fig. 8.

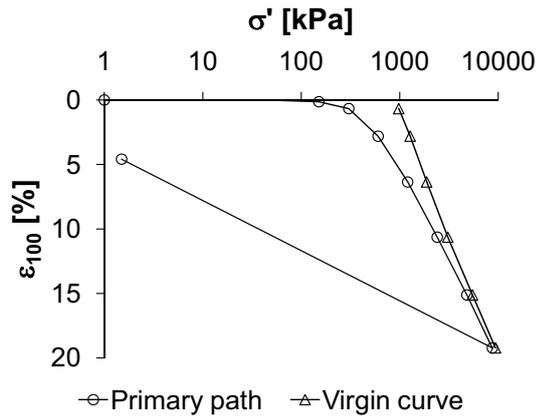
**Figure 9:** Primary path and virgin curve of the first consolidation test.

The primary path and the virgin curve of the load–displacement curve can be seen in Fig. 9.

The preconsolidation stress is found to  $\sigma'_{pc} = 1350$  kPa which implies an overconsolidation ratio of approximately  $OCR = 6.8$ . Additionally, estimations based on Akai's method, Janbu's method and the coefficient of consolidation, cf. Figs. 10–12, have been investigated leading to  $\sigma'_{pc}$  in the range 1200 – 1800 kPa.

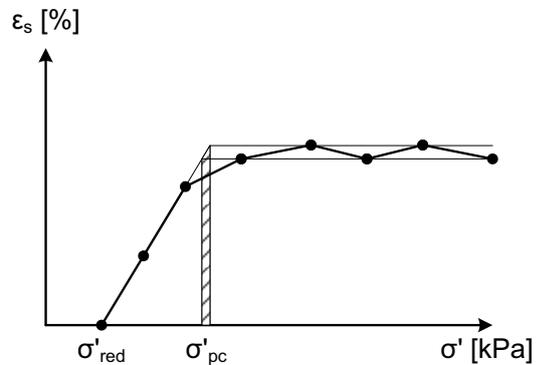
**Figure 10:** Akai's method of determining  $\sigma'_{pc}$ .  $\sigma'_{red}$  is the lowest effective stress of the soil. According to Moust Jacobsen (1993, Fig. 5.13).

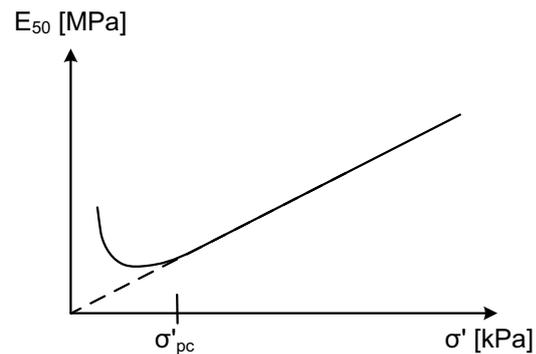
**Figure 11:** Janbu's method of determining  $\sigma'_{pc}$  based on the secant modulus  $E_{50}$ .

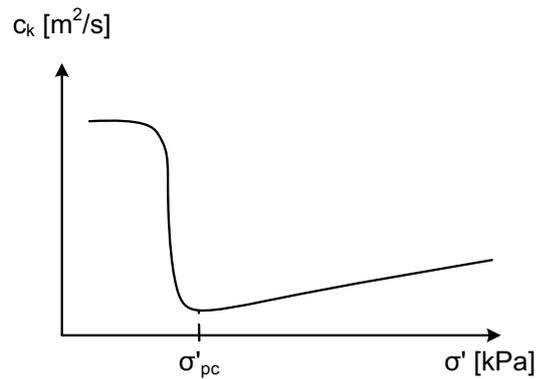
**Figure 12:** Determination of  $\sigma'_{pc}$  based on the coefficient of consolidation  $c_k$ . According to Thøgersen (2001, Fig. 5.9).

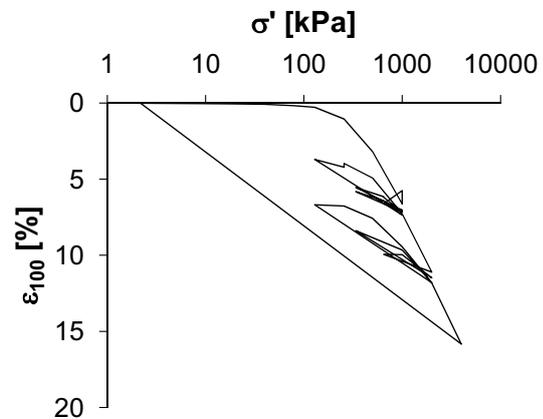
**Figure 13:** Primary path and unloading/reloading paths of the second consolidation test.

The primary path of the second consolidation test can be seen in Fig. 13.

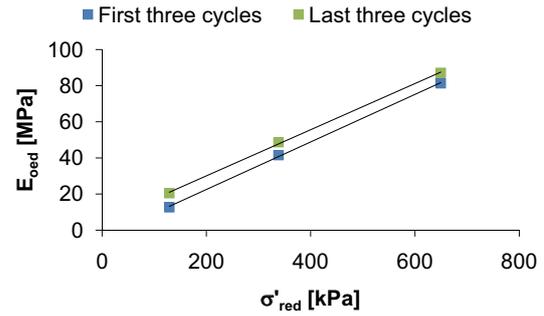
**Figure 14:** Initial slopes for the first three cycles and the last three cycles based on the first and last points of each reloading path.

As an approximation of the constrained modulus, a linear regression between the first and last points of each reloading path is applied. This leads to the relation in Eq. 5 for the first three cycles and in Eq. 6 for the last three cycles, cf. Fig. 14.

$$E_{oed,1} = -3818 + 132 \cdot \sigma'_{red} \quad [\text{kPa}] \quad (5)$$

$$E_{oed,2} = 4560 + 128 \cdot \sigma'_{red} \quad [\text{kPa}] \quad (6)$$

In Eq. 5, the constrained modulus starts as a negative value. This is not realistic and Eq. 6 is used as an approximation of  $E_{oed}$ . For comparison, the constrained modulus of the tertiary Søvind Marl is approximately  $E_{oed} = 10000 + 150 \cdot \sigma'_{red}$  (Johannesen et al., 2008).

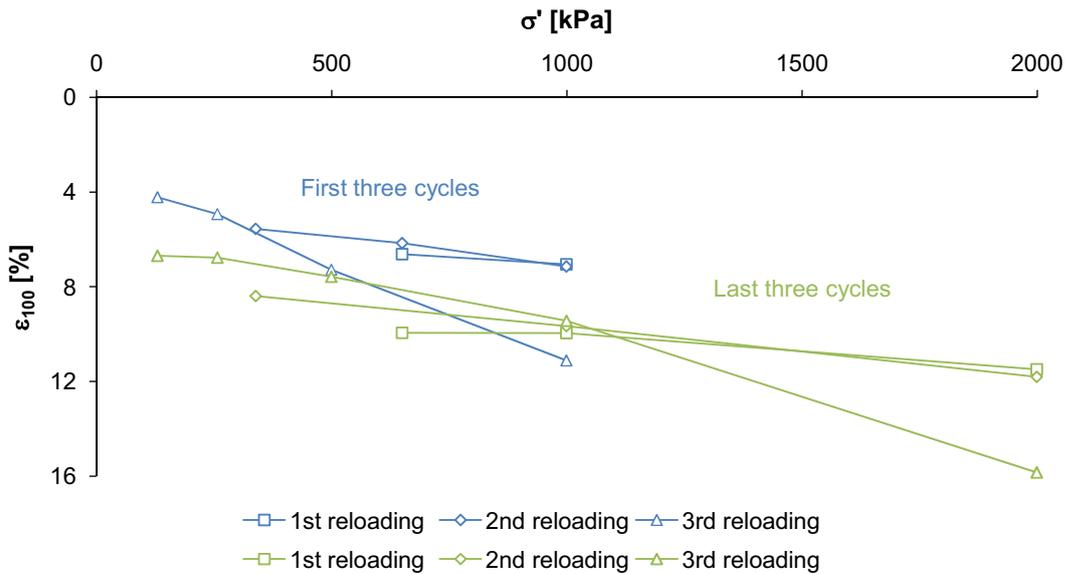
Figure 15: Reloading paths for the second consolidation test.

The reloading paths can be seen in Fig. 15. As seen in the figure, the magnitude of  $E_{oed}$  for each reloading path depends on the choice of considered points. Choosing for example the first two points of the first reloading path for the second three cycles, i.e. (650 kPa, 9.9 %) and (999 kPa, 10.0 %), leads to  $E_{oed} = 1748$  MPa, whereas the first and last point of this reloading path, i.e. i.e. (650 kPa, 9.9 %) and (1999 kPa, 11.5 %), leads to  $E_{oed} = 87$  MPa. The constrained moduli for alle parts of the reloading paths are listed in Tab. 3.

As seen in Fig. 15 and Tab. 3, the constrained modulus depends significantly on the investigated stress level. Hence, multiple relations based on Eq. 4 for different stress levels could be a method of obtaining realistic values of  $E_{oed}$  in the future.

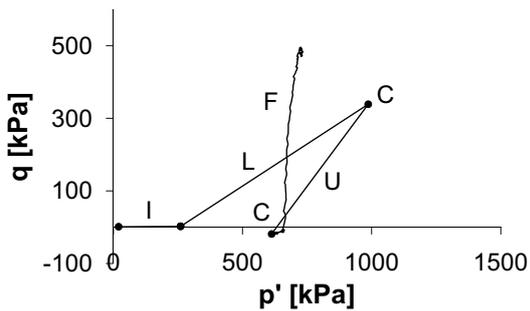
Figure 16: The effective mean stress  $p'$  as a function of the deviatoric stress  $q$ . I: Installation, L: Loading, C: Consolidation, U: Unloading, F: Failure.

The strength properties of the tertiary clay at Moesgaard Museum are determined by a  $CAU_{u=200}$  triaxial test with  $H = D = 70$  mm and smooth pressure cells. The test is conducted according to Laboratoriehåndbogen (DGF's Laboratoriekomité, 2001). The loading phase is conducted as an anisotropic loading controlled by the coefficient of horizontal earth pressure at rest  $K_0$ . The specimen is unloaded with constant  $K_0$ . The effective mean stress  $p'$  as a function of the deviatoric stress  $q$  can be seen in Fig. 16.

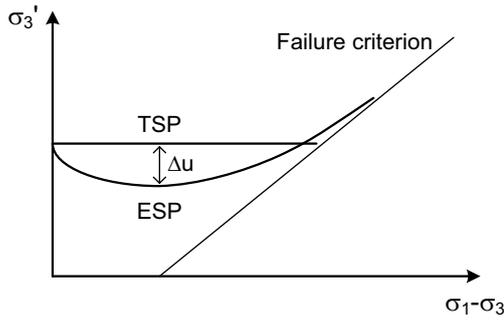
**Figure 17:** Total stress path (TSP), effective stress path (ESP) and failure criterion for undrained triaxial tests.

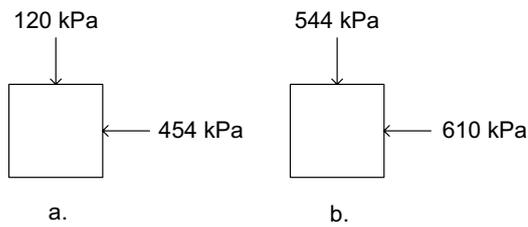
**Figure 18:** a. Desired stress levels after unloading. b. Actual stress levels after unloading.

the test. This does, however, not have any significant consequence because the effective stress path and not the total stress path is followed during an undrained triaxial test, cf. Fig. 17. Problems appeared with the unloading equipment. This implied that the specimen was not unloaded to the desired stress level, cf. Fig. 18, and, thus, with a varying  $K_0$ .

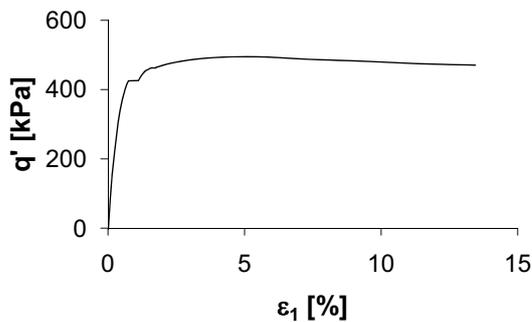
**Figure 19:** The axial strain as a function of the deviatoric stress.

The axial strain  $\varepsilon_1$  is plotted as a function of the effective deviatoric stress  $q'$  in Fig. 19.

additional strain is found to  $q = 495$  kPa leading to  $c_u = 247.5$  kPa. This corresponds well with the vane shear strength of  $c_v = 280$  kPa which indicates a non-fissured clay.

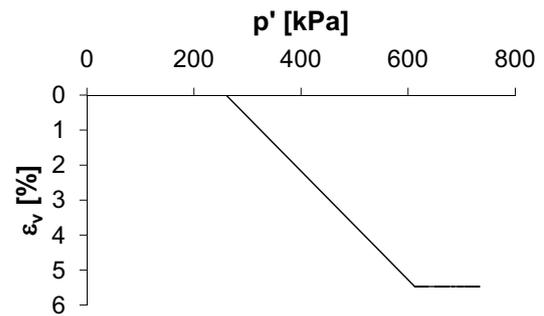
**Figure 20:** Volumetric strains  $\varepsilon_v$  as a functions of the effective mean stress  $p'$ .

For preconsolidated clays, the soil tends to dilate during loading. As seen in Fig. 20, this is not the case for the present triaxial test.

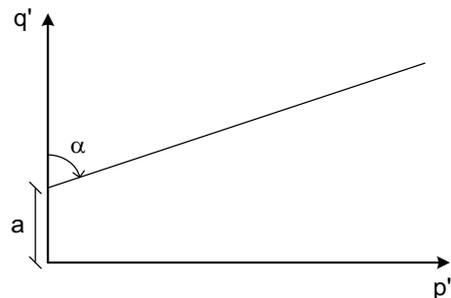
**Figure 21:** Failure criterion of triaxial test.

The parameters  $\alpha$  and  $a$  are found by the failure criterion, cf. Fig. 21.

Because only a single failure point is found by the triaxial test, it is difficult to plot a unique failure criterion, cf. Fig. 21. Thus, both a solution including a cohesion defined by the parameter  $a$

and a solution intersecting with  $(0, 0)$  are used. This leads to  $(c'_{tr}, \phi'_{tr}) = (0, 17.8^\circ)$  and  $(c'_{tr}, \phi'_{tr}) = (47.1 \text{ kPa}, 14.5^\circ)$ , respectively. It should be noted, though, that for the simple relation  $c' = 0.1 \cdot c_u$ , the value of  $c'_{tr} = 47.1 \text{ kPa}$  implies  $c_u = 471 \text{ kPa}$ . This value is almost twice the undrained shear strength determined earlier as  $c_u = 247.5 \text{ kPa}$ . Hence, the second set of drained strength parameters including a cohesion is considered unrealistically high.
