*Published in:*  
Energy and Buildings

# Passive house renovation of a block of flats – Measured performance and energy signature analysis

Jørgen Rose<sup>a,\*</sup>, Jesper Kragh<sup>a</sup>, Kasper Furu Nielsen<sup>b</sup>

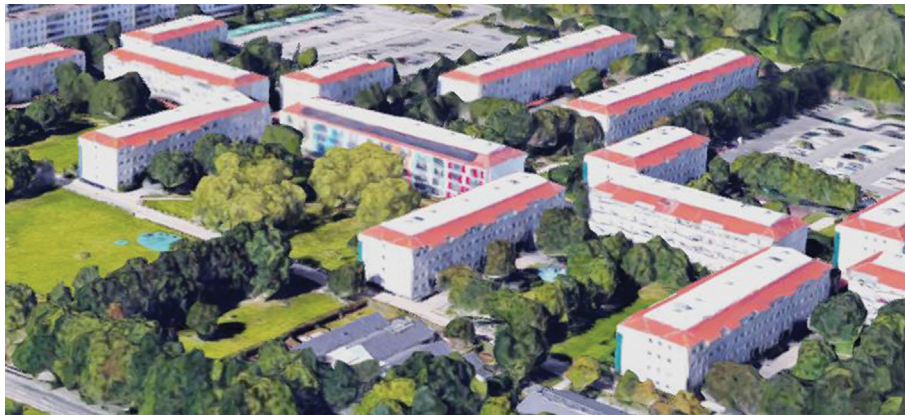
**Fig. 1.** Aerial view of Gadehavegård (Photo: Google Maps).

Gadehavegård is a social housing built-up area erected during 1977–1982 with 987 apartments and a total heated area of approx. 76 000 m<sup>2</sup> spread over 19 blocks of flats in four stories. It has approximately 2 500 tenants and is one of the largest public housing units in the municipality of Høje-Taastrup. The demonstration case building has facades facing north and south and consists of 54 apartments with a total heated gross area of 4 218 m<sup>2</sup>. All apartments have windows in both facades. The building has four stories and an unheated basement with an area of 1 243 m<sup>2</sup> where the heating installation is located. The buildings in Gadehavegård are heated by district heating. Fig. 1 shows an aerial view of Gadehavegård.

Due to its age, Gadehavegård was facing a major renovation and modernization and block 9 (visible in the centre of Fig. 1 with the coloured shutters) was selected as a demonstration case for the remaining 18 blocks, i.e. for testing the overall renovation concept.

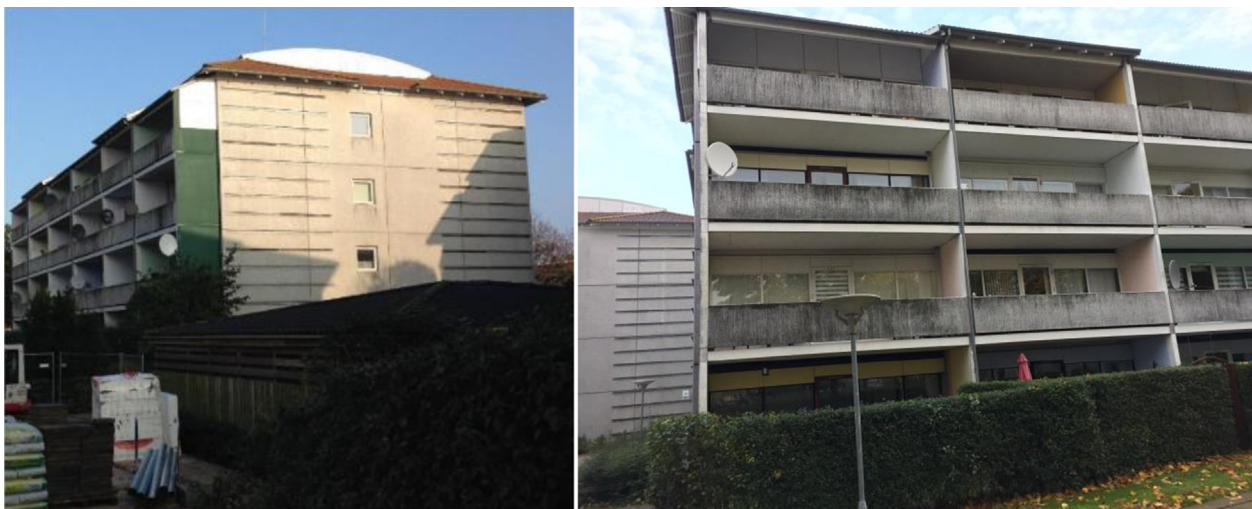
**Fig. 2.** Gable and garden façade before renovation (Photos: Technological Institute).

The walls in the original buildings were prefabricated concrete elements with 125 mm insulation (mean U-value including effects of thermal bridges of 0.57 W/m<sup>2</sup> K) and at balconies a light-weight construction with 125 mm insulation (mean U-value including effects of thermal bridges of 0.38 W/m<sup>2</sup> K). The roof was flat and had 100 mm insulation (U-value of 0.37 W/m<sup>2</sup> K). Windows were traditional 2-pane windows and they had 2–3 sashes each (U-value of 2.93 W/m<sup>2</sup> K and SHGC of 0.76). The horizontal division above the basement was 250 mm concrete with 100 mm insulation (U-value of 0.35 W/m<sup>2</sup> K) and the basement walls were 350 mm concrete (U-value of 3.70 W/m<sup>2</sup> K). The concrete constructions created several very large thermal bridges in the buildings, e.g., in assemblies between concrete elements and in roof/wall- and wall/floor assemblies, which is also evident in e.g., wall mean U-values. The thermal bridges created problems with the indoor climate in the form of mould and moisture in the apartments, and therefore one of the main purposes of the renovation was to remove/reduce the thermal bridges and improve indoor climate and avoid health risks. Fig. 2 shows the gable and the garden façade of one of the blocks before the renovation.

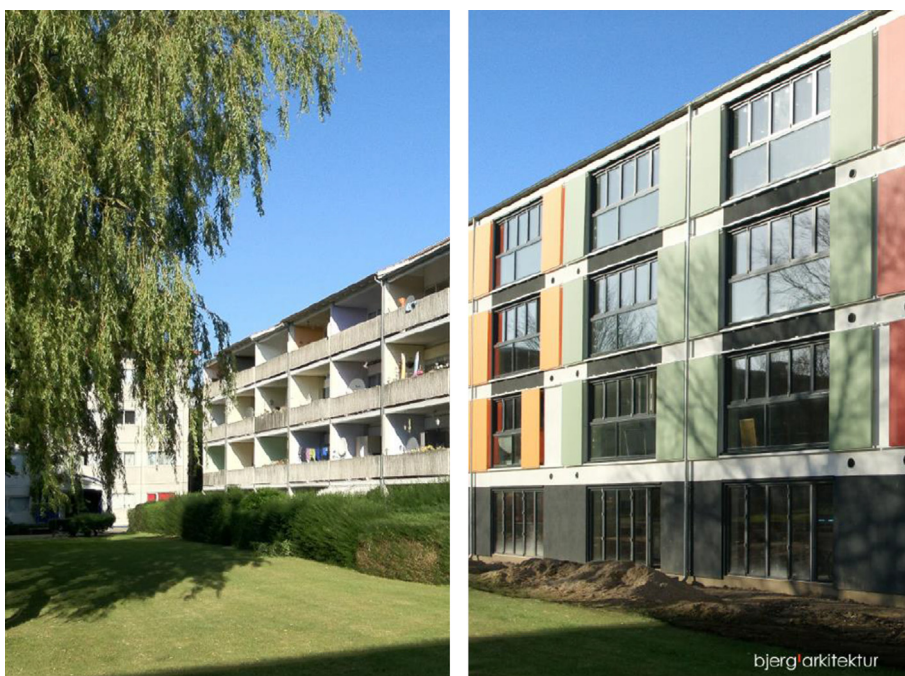
**Fig. 3.** Balconies of Gadehavegård before (left) and after (right) renovation (Photos: Bjerg Arkitektur).

The renovation of the building has allowed for alteration of the building's existing floor plan. It was chosen to focus on the balconies, which after the renovation are closed balconies with windows that can be fully opened, so that the balcony can appear open during the warmer periods of the year. The new façade of the closed balcony is well insulated and has energy efficient glazing. Hereby, the heat from the sun is utilized during transition periods, while shutters can remedy overheating in the summer. The inclusion of balconies to the apartments adds 14-m<sup>2</sup> floor area per apartment, i.e. 754 m<sup>2</sup> for the entire building. Fig. 3 shows the façade facing the garden before and after renovation, demonstrating how the balconies have now been included in the apartments. The coloured shutters can be moved to protect against direct sunlight during warm periods.

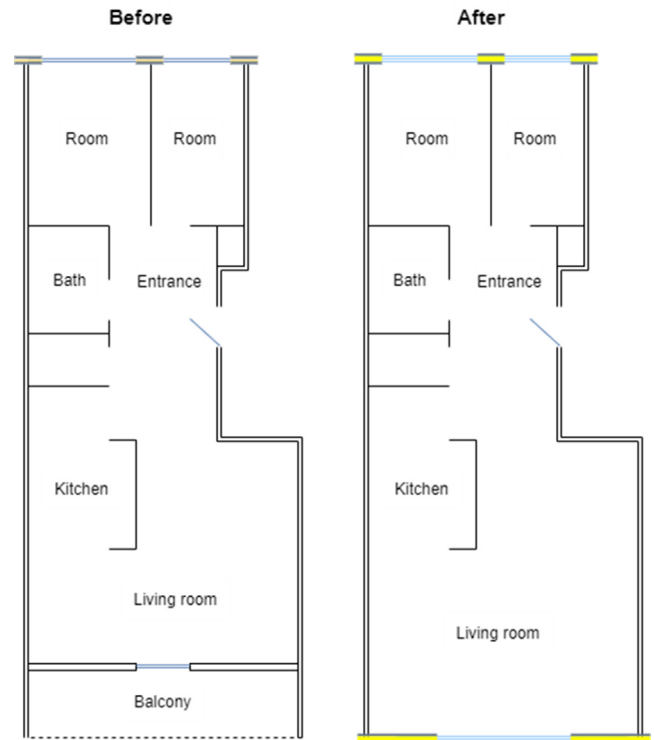
**Fig. 5.** Sketch of the apartment layout before and after renovation.

Fig. 5 shows a sketch of the apartment layout before and after renovation, demonstrating how the balconies are included as part of the heated area.
