Accelerated climate aging tests of structural insulated panels with waste-based core materials

Roberta Moschetti¹, Lars Gullbrekken¹ and Joana Maia²

¹SINTEF Community, Trondheim, Norway

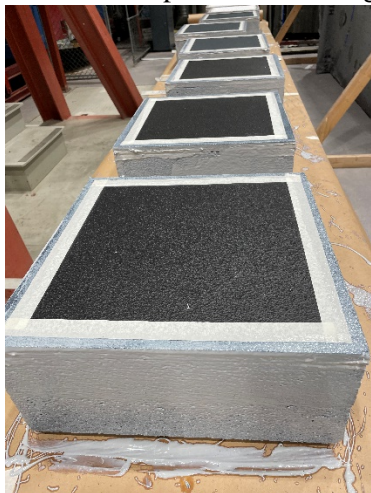
All the samples before testing

Figure 2 Pictures of the different samples before (upper left corner) and after the testing in the climate simulator.
