European Experience of Low Crested Structures for Coastal Management

European experience of low crested structures for coastal management

This paper aims to describe selected study sites monitored and analyzed during the DELOS project. All the selected sites are protected by Low Crested Structures (LCSs) under various environmental conditions.

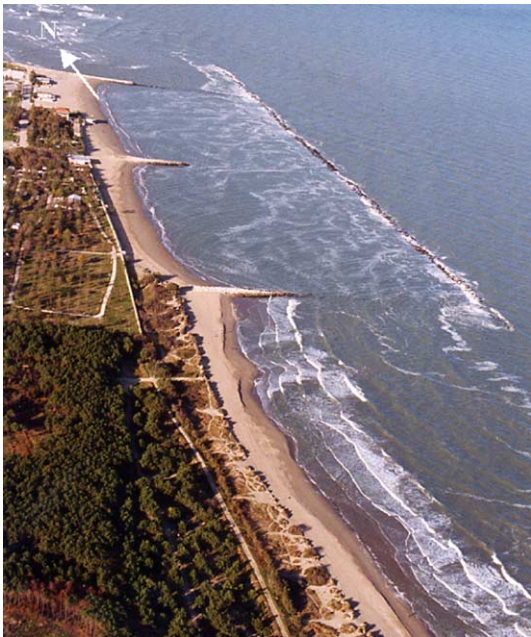
Fig. 11. Perspective view of the shore-protection system defending Lido di Dante beach.

water level. Beach nourishments using sand with $D_{n50}=0.23$ mm were performed: 60,000 m³ in 1993 and 74,400 m³ in 1996. A view of the beach is shown in Fig. 11. A detailed description of the site and the design of the structures can be found in Lamberti et al. (2002) and Archetti et al. (2004).

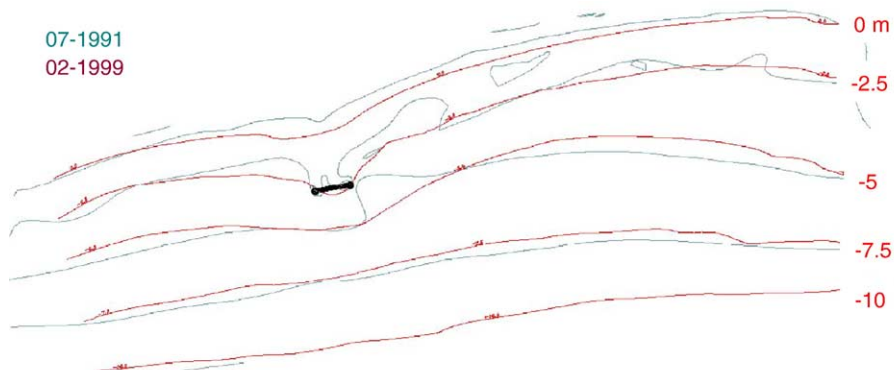
Fig. 13. Comparison between 07-1991 and 02-1999 Altafulla bathymetries.

In [Fig. 13](#), the first and last available bathymetries are shown. It can be observed how the greatest changes have occurred in the lee side of the structure. The irregularities observed on the right side of the 1991 bathymetry can be attributed to the nourishment made 3 months before the measurements.
