European experience of low crested structures for coastal management

A. Lamberti ^{a,*}, R. Archetti ^a, M. Kramer ^b, D. Paphitis ^c,
C. Mosso ^d, M. Di Risio ^e

Abstract

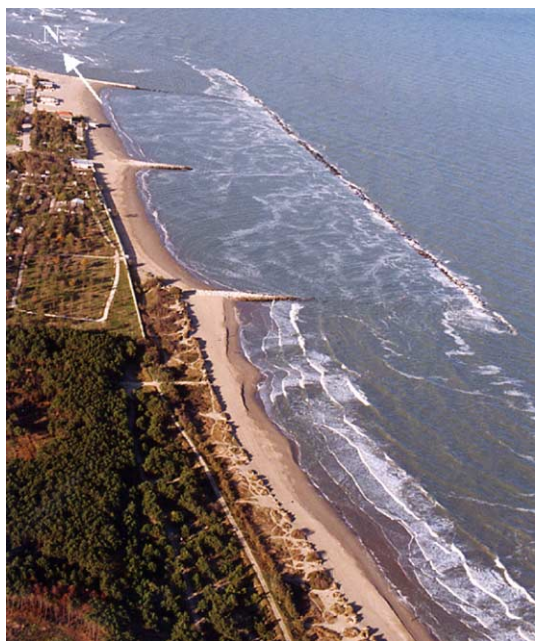
Fig. 11. Perspective view of the shore-protection system defending Lido di Dante beach.

water level. Beach nourishments using sand with $D_{n50}=0.23$ mm were performed: 60,000 m³ in 1993 and 74,400 m³ in 1996. A view of the beach is shown in Fig. 11. A detailed description of the site and the design of the structures can be found in Lamberti et al. (2002) and Archetti et al. (2004).

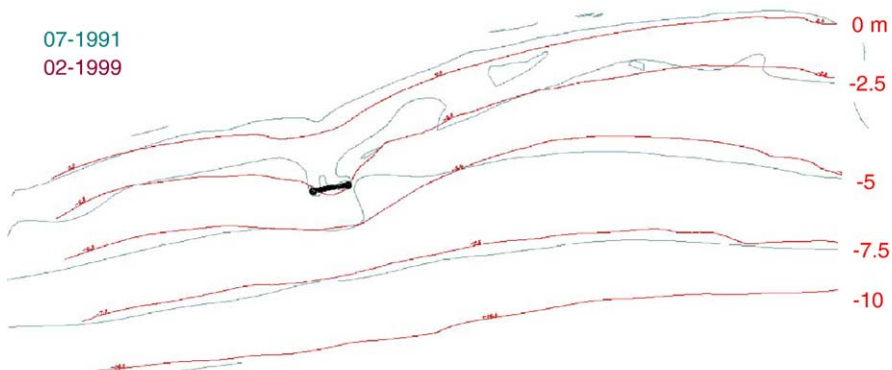
Fig. 13. Comparison between 07-1991 and 02-1999 Altafulla bathymetries.

In [Fig. 13](#), the first and last available bathymetries are shown. It can be observed how the greatest changes have occurred in the lee side of the structure. The irregularities observed on the right side of the 1991 bathymetry can be attributed to the nourishment made 3 months before the measurements.

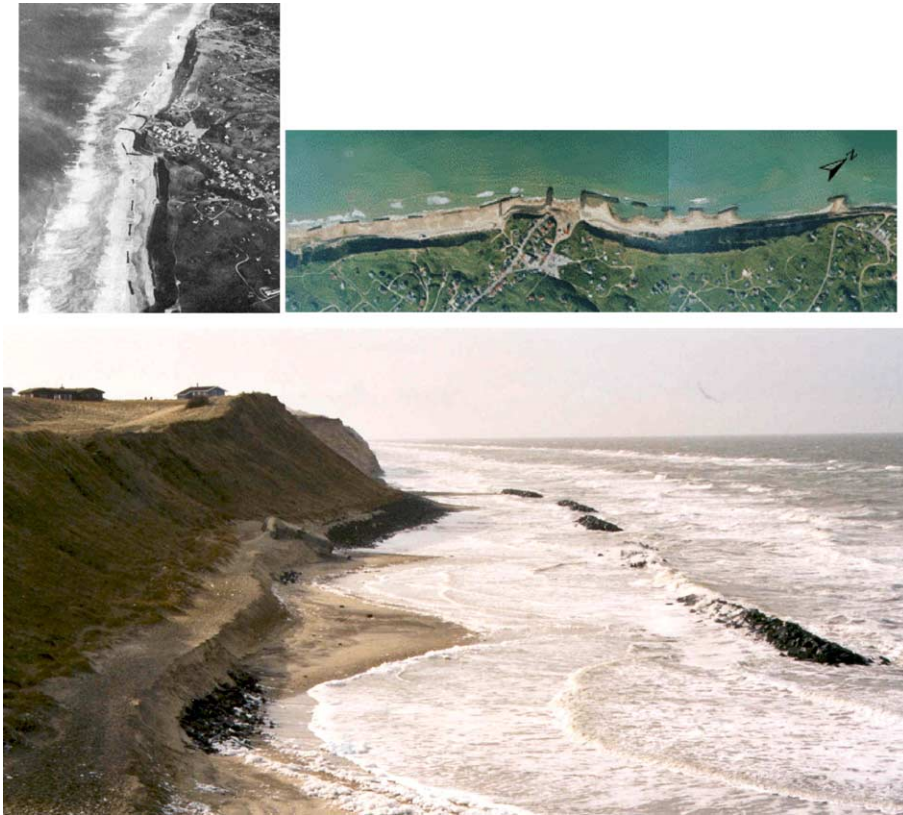
Fig. 15. Pictures of the study site at Lønstrup.

The map in Fig. 14 shows the location of Lønstrup and a picture of the breakwater is given in Fig. 15. A system of breakwaters is placed both north and south of this site. The breakwaters were built to protect the small village Lønstrup located near the sea and the adjacent beaches from the ongoing coastal erosion caused by the North Sea waves. The most frequent wind direction is from West and South West where the strongest winds also occur. Due to the large fetch in Western direction the waves and the storm set-up is large during autumn storms. If unprotected the coast at Lønstrup will erode 1.5 m/year. In fact during a storm back in 1981 some places were eroded up to 15 m. This event induced the construction of the protection scheme in 1982/1983.
