European Experience of Low Crested Structures for Coastal Management

European experience of low crested structures for coastal management

This paper aims to describe selected study sites monitored and analyzed during the DELOS project. All the selected sites are protected by Low Crested Structures (LCSs) under various environmental conditions.

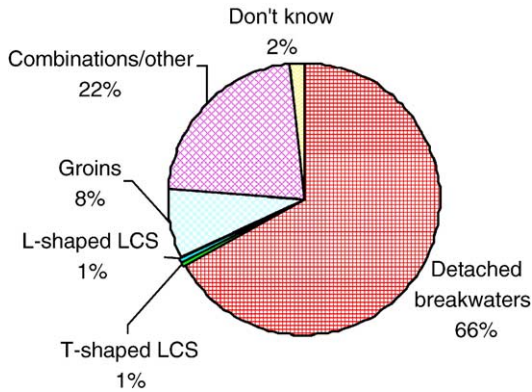
Fig. 2. Types of low crested structures in Europe.

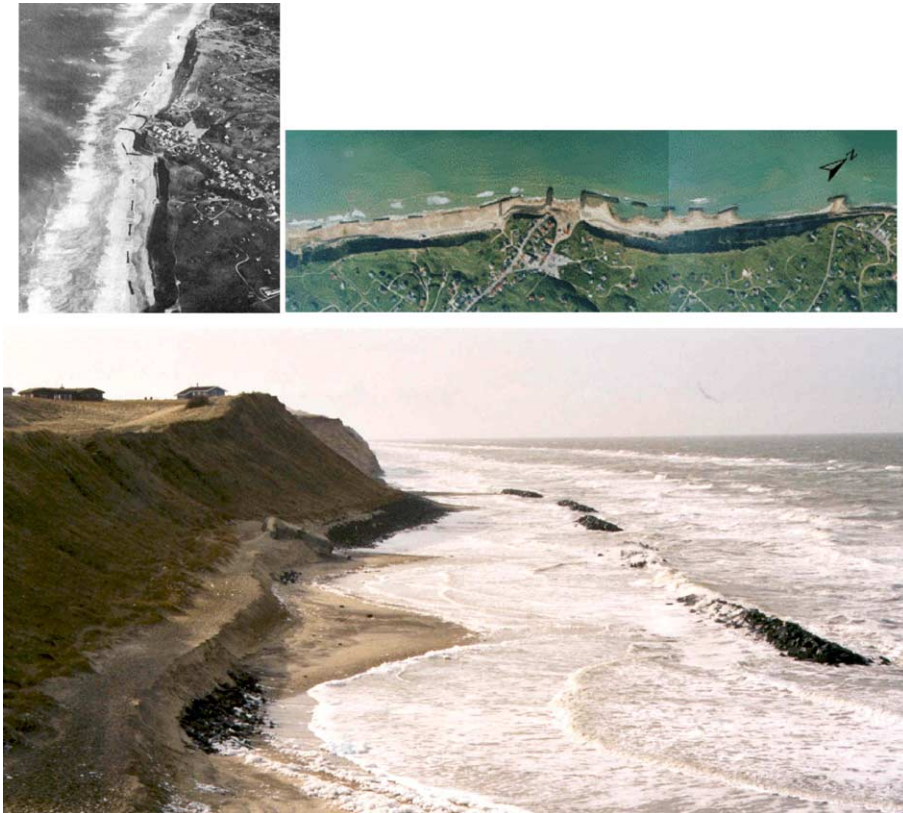
Fig. 15. Pictures of the study site at Lønstrup.

The map in Fig. 14 shows the location of Lønstrup and a picture of the breakwater is given in Fig. 15. A system of breakwaters is placed both north and south of this site. The breakwaters were built to protect the small village Lønstrup located near the sea and the adjacent beaches from the ongoing coastal erosion caused by the North Sea waves. The most frequent wind direction is from West and South West where the strongest winds also occur. Due to the large fetch in Western direction the waves and the storm set-up is large during autumn storms. If unprotected the coast at Lønstrup will erode 1.5 m/year. In fact during a storm back in 1981 some places were eroded up to 15 m. This event induced the construction of the protection scheme in 1982/1983.
