European Experience of Low Crested Structures for Coastal Management

European experience of low crested structures for coastal management

This paper aims to describe selected study sites monitored and analyzed during the DELOS project. All the selected sites are protected by Low Crested Structures (LCSs) under various environmental conditions.

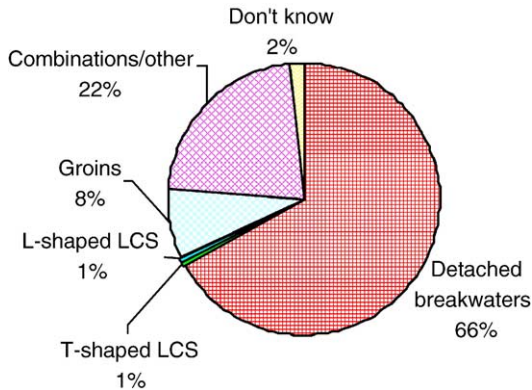
Fig. 2. Types of low crested structures in Europe.
