Innovation and procurement strategies and practices

SUSTAINABLE REFURBISHMENT BY PUBLIC CLIENTS: INNOVATION AND PROCUREMENT STRATEGIES AND PRACTICES

SBI 2013:33

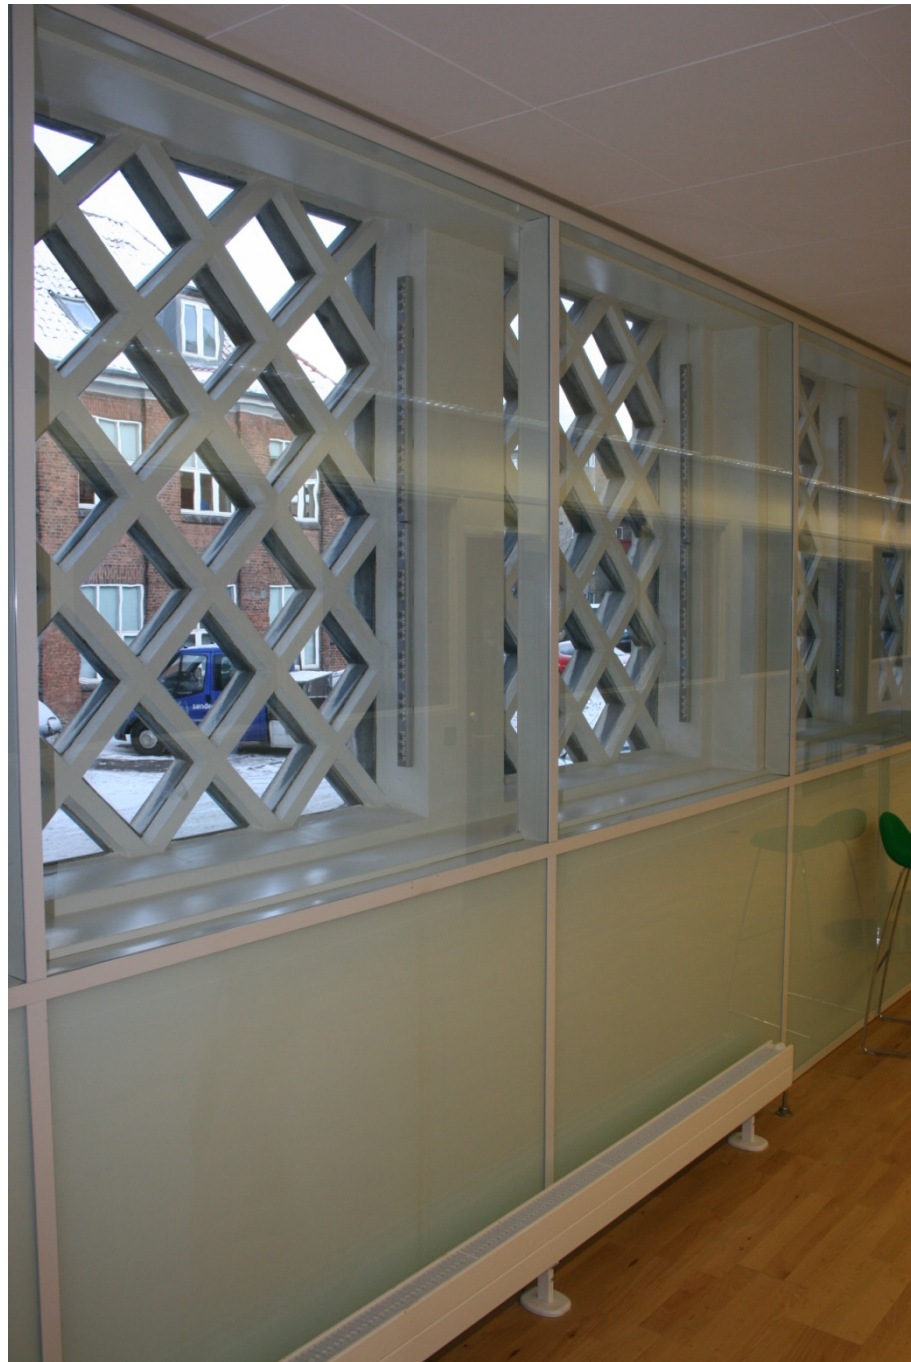
Figure 70. A solution was chosen where the whole facade was placed behind a "glass wall" (from the inside) as the very special windows could not be renovated in ordinary ways. Photo: (Kim Haugbølle).

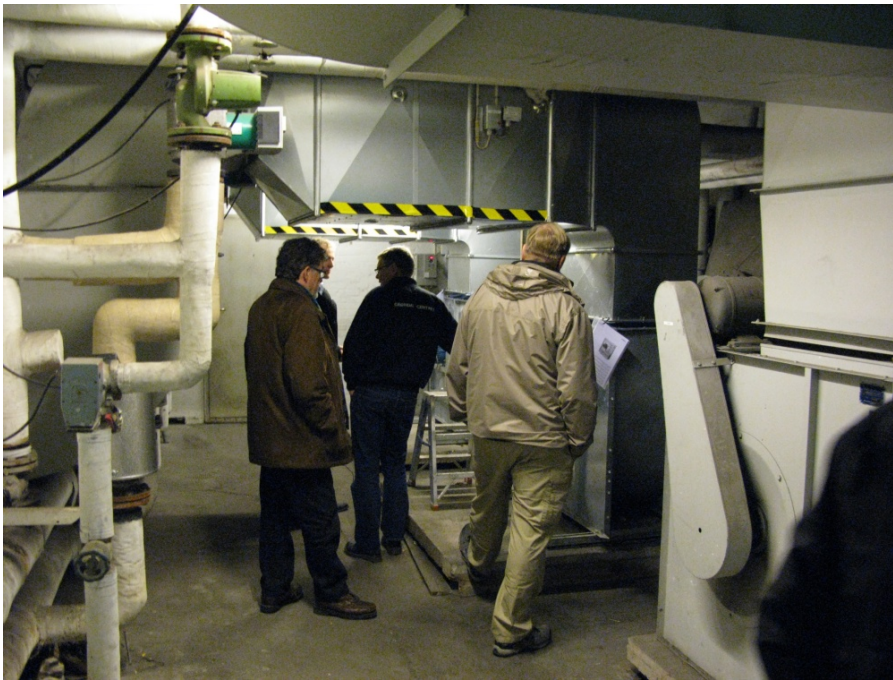
Figure 75. The old heating system is still working, but is part by part being renewed. Photo: (Peter Vogelius).

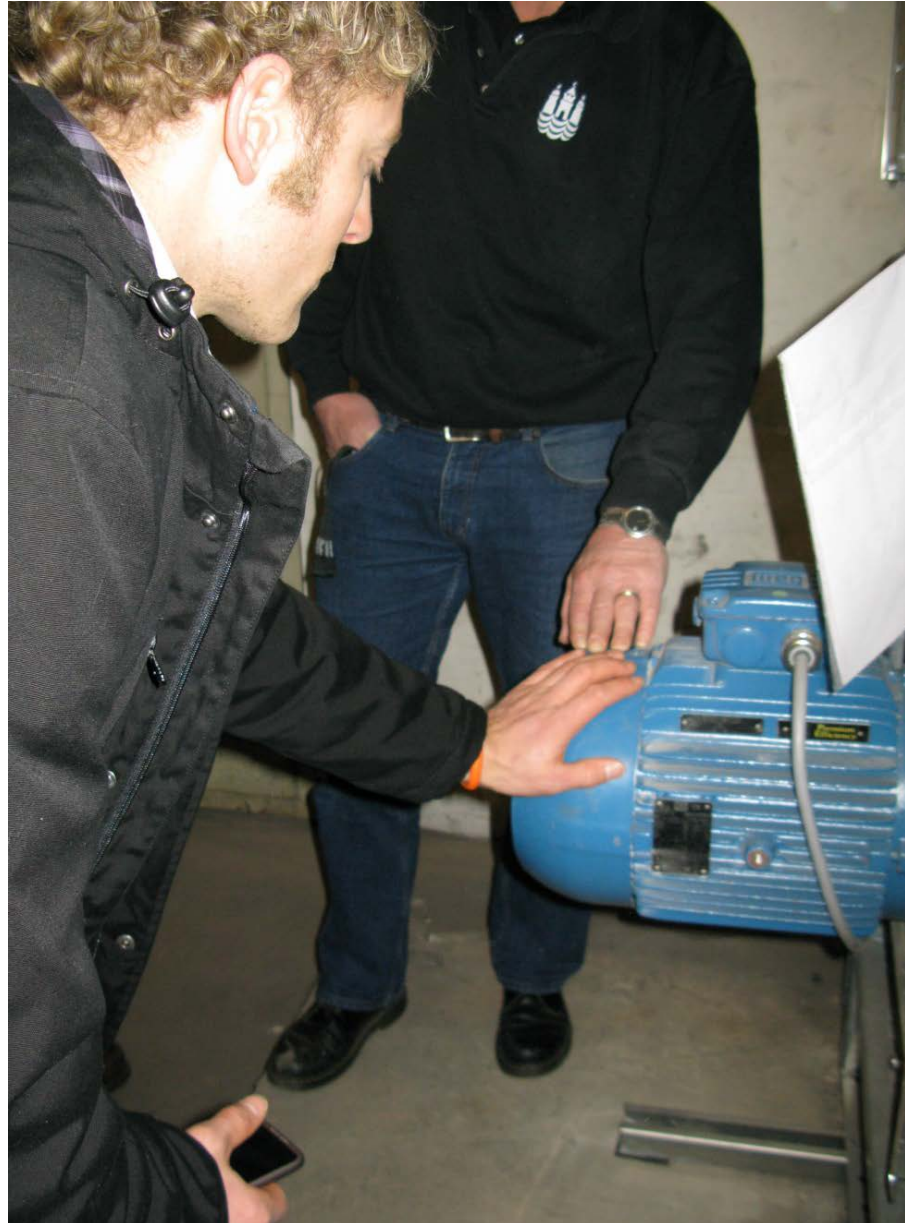
Figure 76. Circulation pumps are replaced mostly by low-energy models, which also facilitate and interface to the intranet. Photo: (Peter Vogelius).

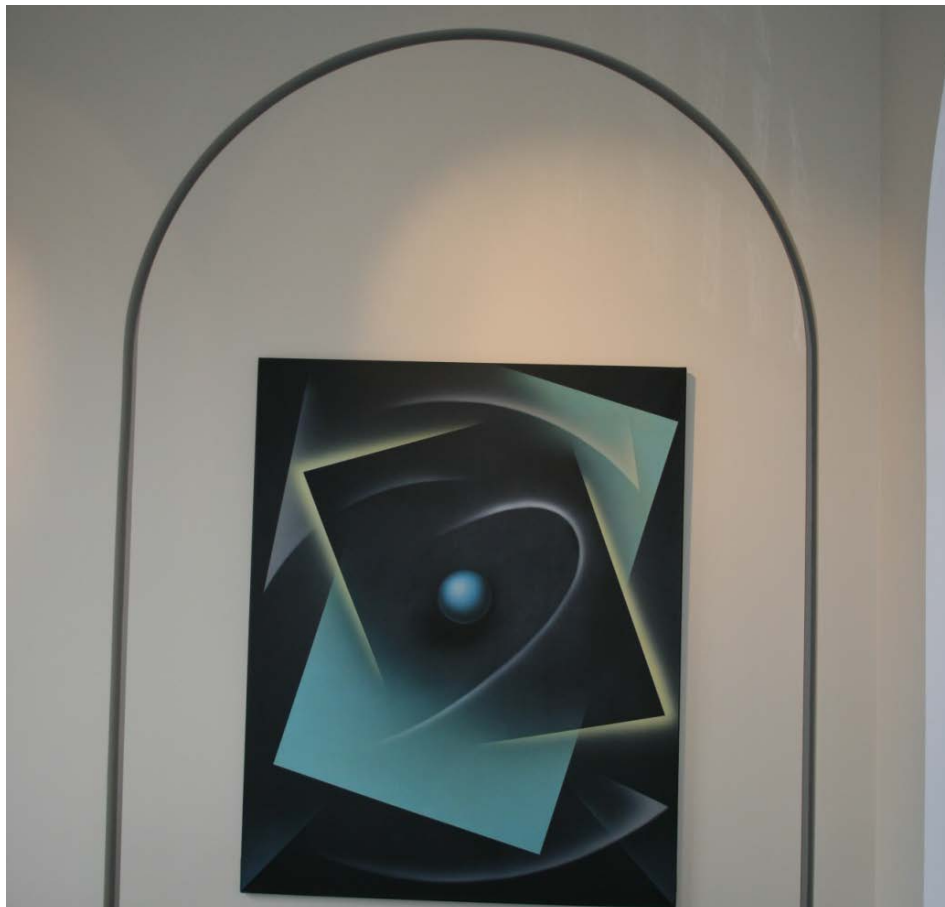
Figure 83. Ventilation system integrated in the wall. The painting on the wall is "From space to space" by Finn Mickelborg in 1995. Photo: Kim Haugbølle.

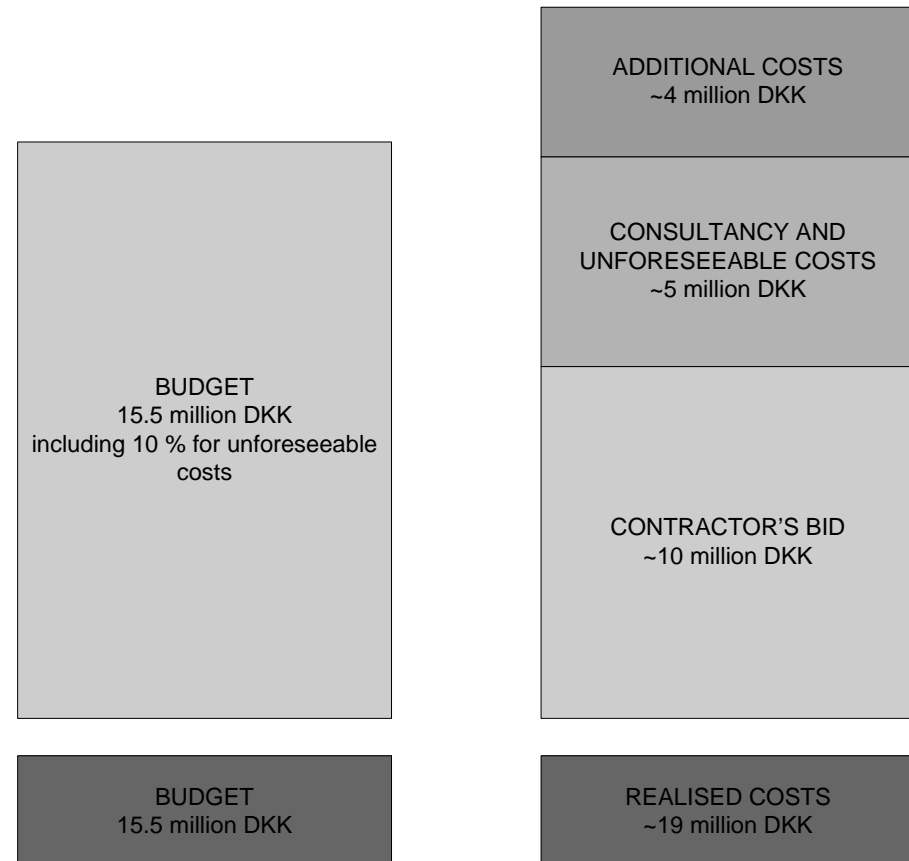
Figure 84. Illustration of the budget and realised costs for the refurbishment (without VAT).

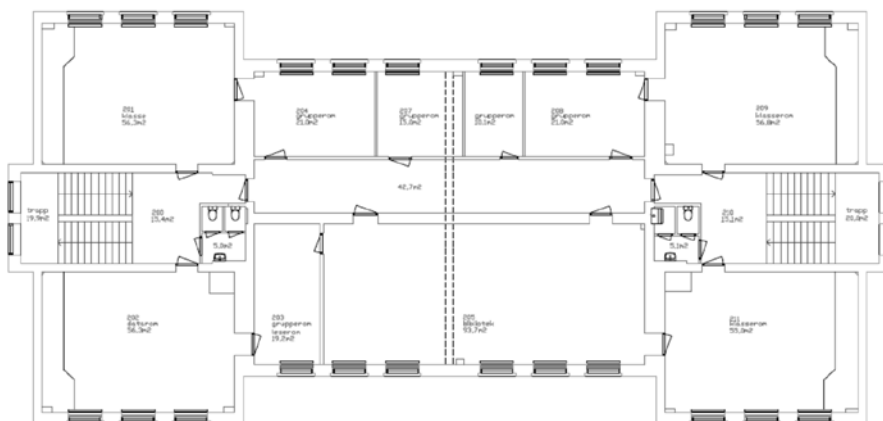
Figure 93. Floor plan of first floor. Source: (Drammen Eiendom KF).

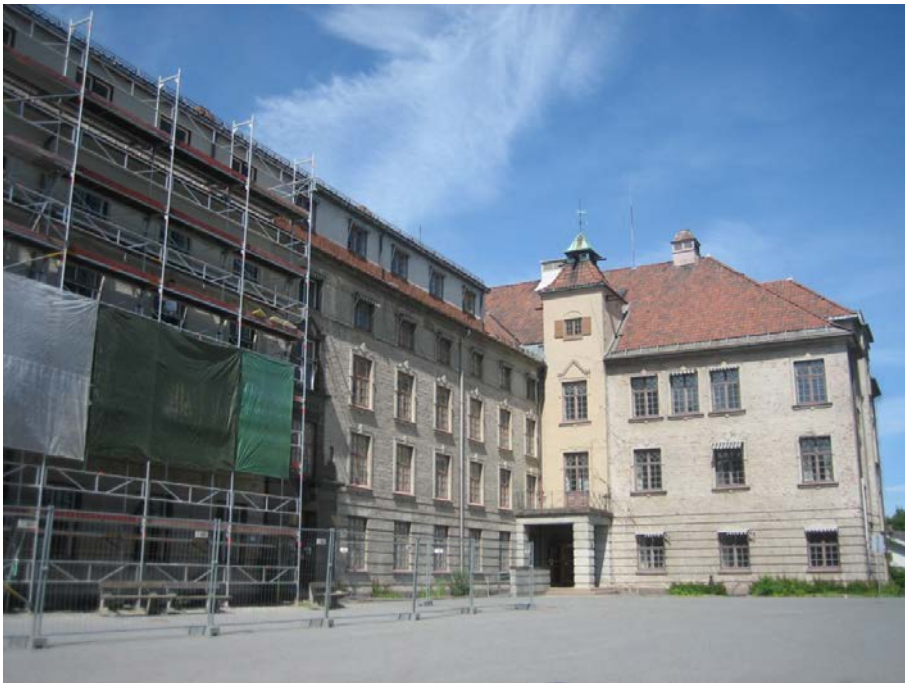
Figure 96. Part of Ringstabekkveien 105. The façade is protected and is now being maintained. Photo: (Anders-Johan Almås).

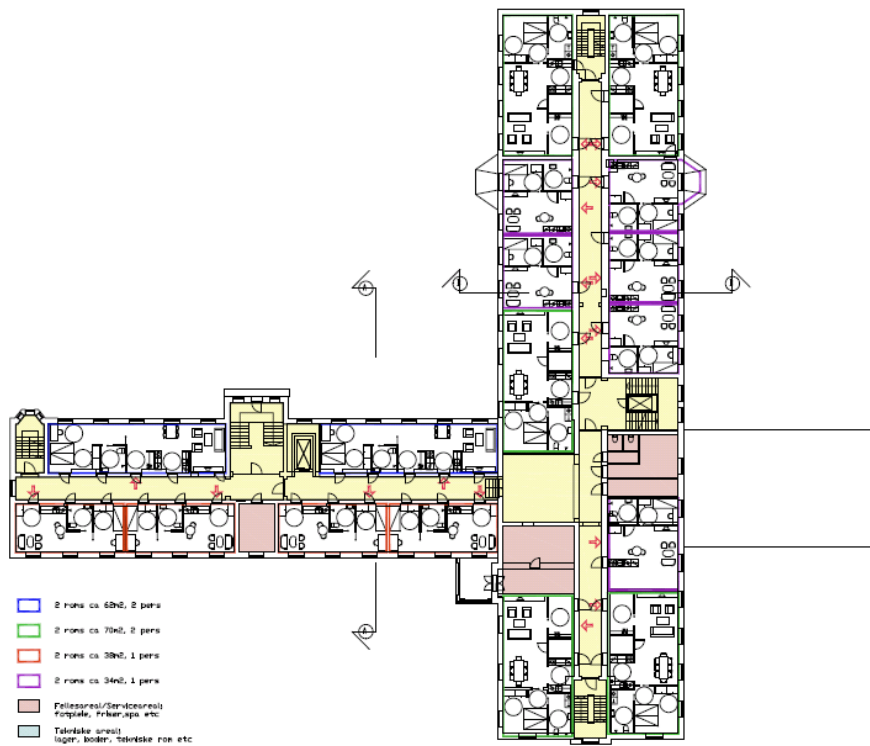
Figure 99. Second floor, as planned with apartments. Source: (Optimo – Entra Eiendom).

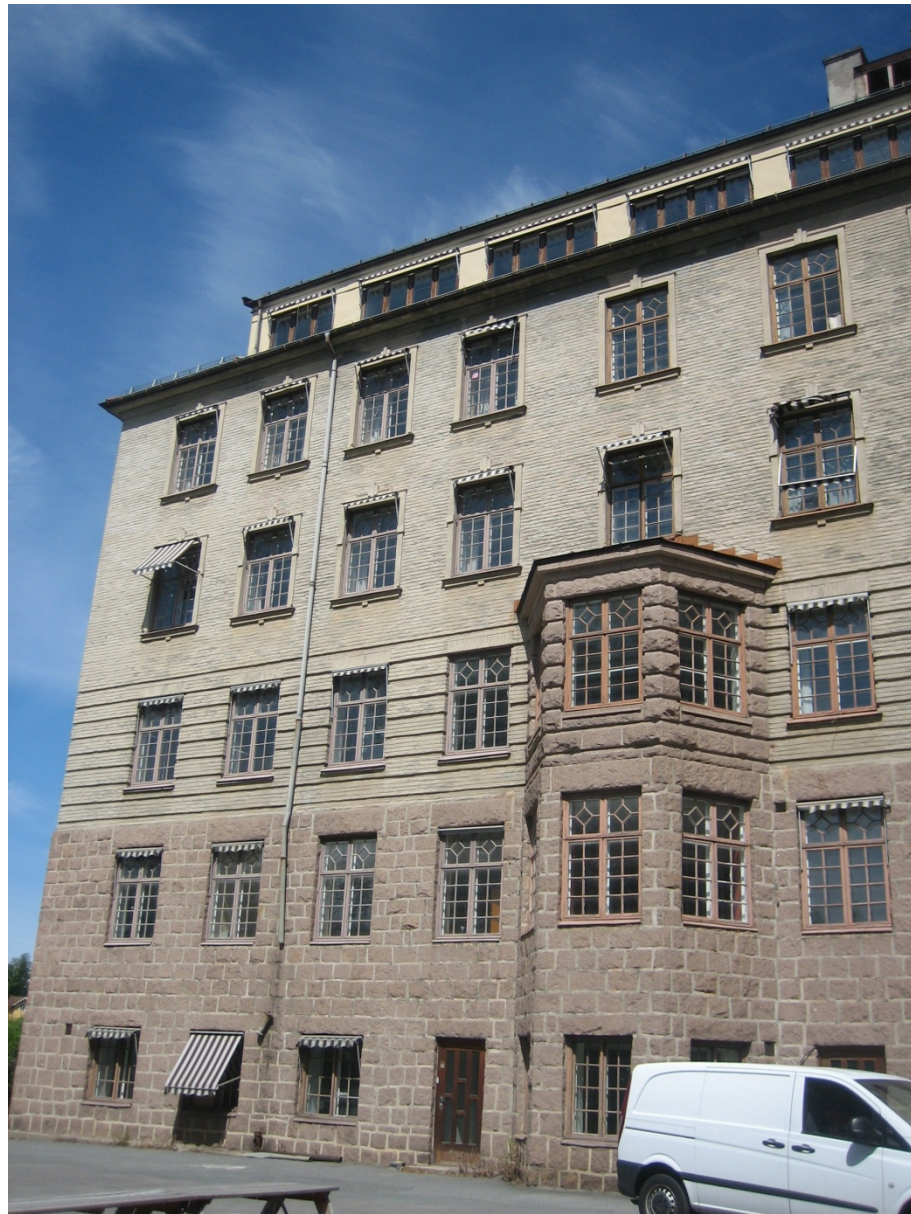
Figure 100. Outer wall façade. There is a clear distinction between the stone wall and the brick wall. Photo: (Anders-Johan Almås).

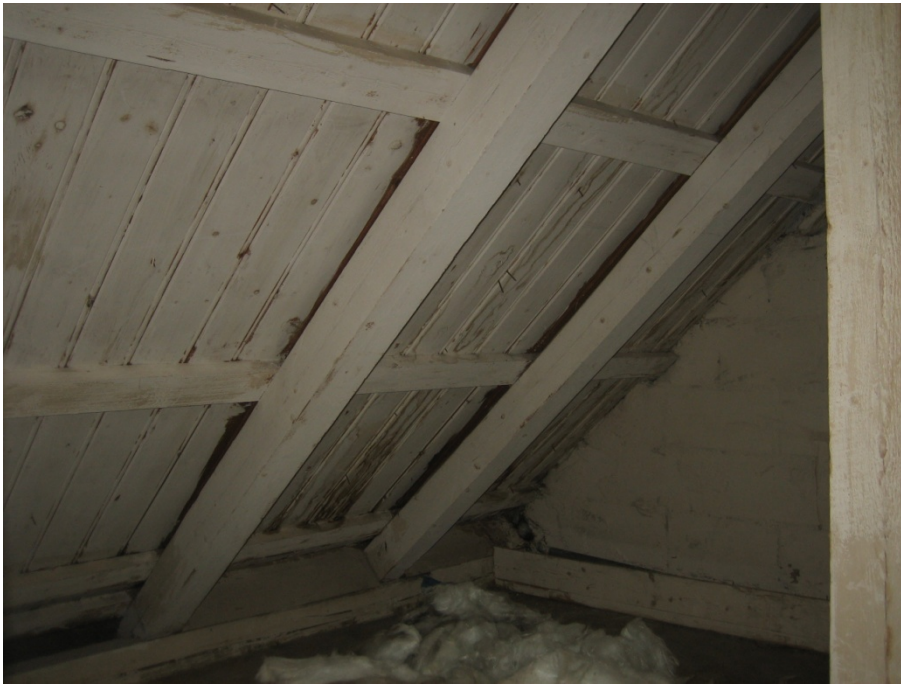
Figure 101. The roof seen from the cold attic. Photo: (Anders-Johan Almås).

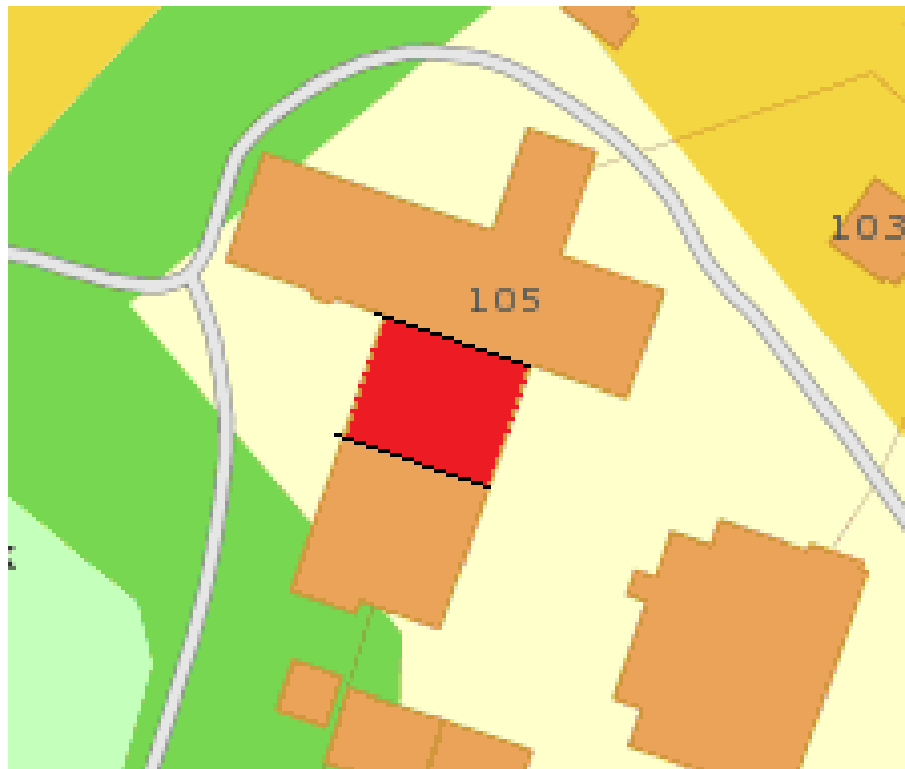
Figure 103. The air tightness was tested in the red area. Source: Adapted by Anders-Johan Almås.

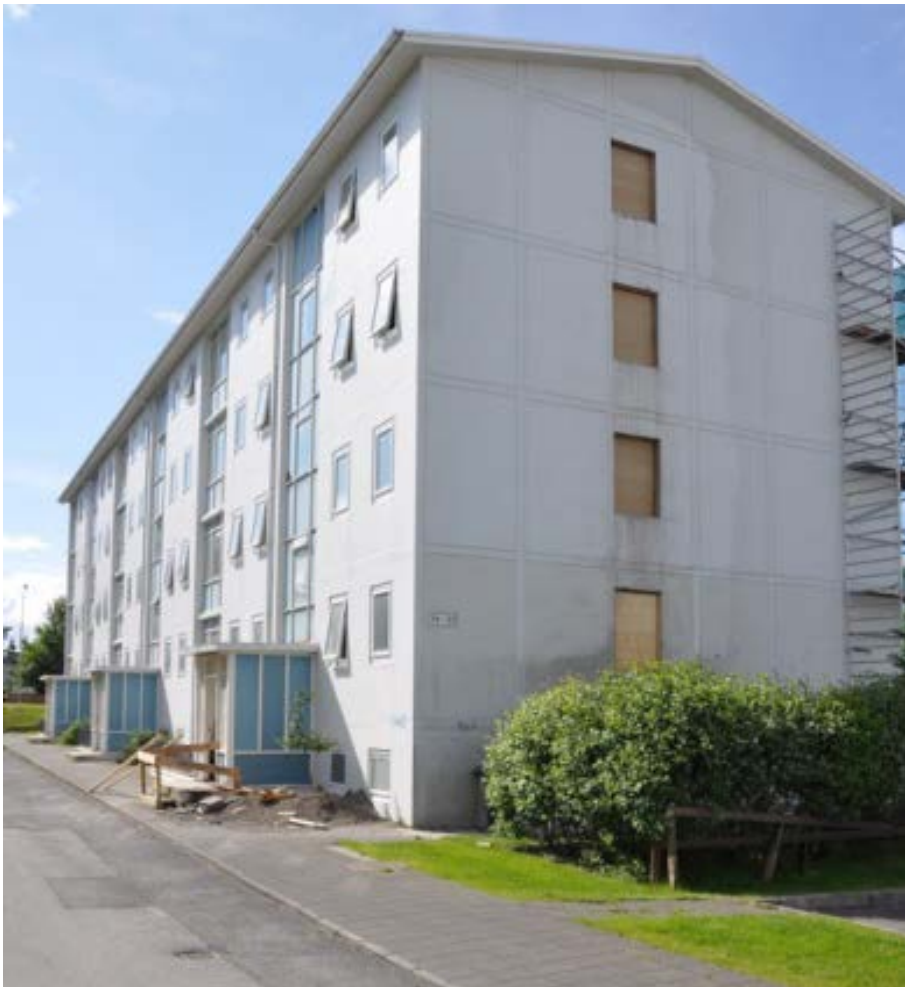
Figure 108. North view. New window openings have been cut out on the gable wall (during refurbishment). Photo: (Björn Marteinsson).

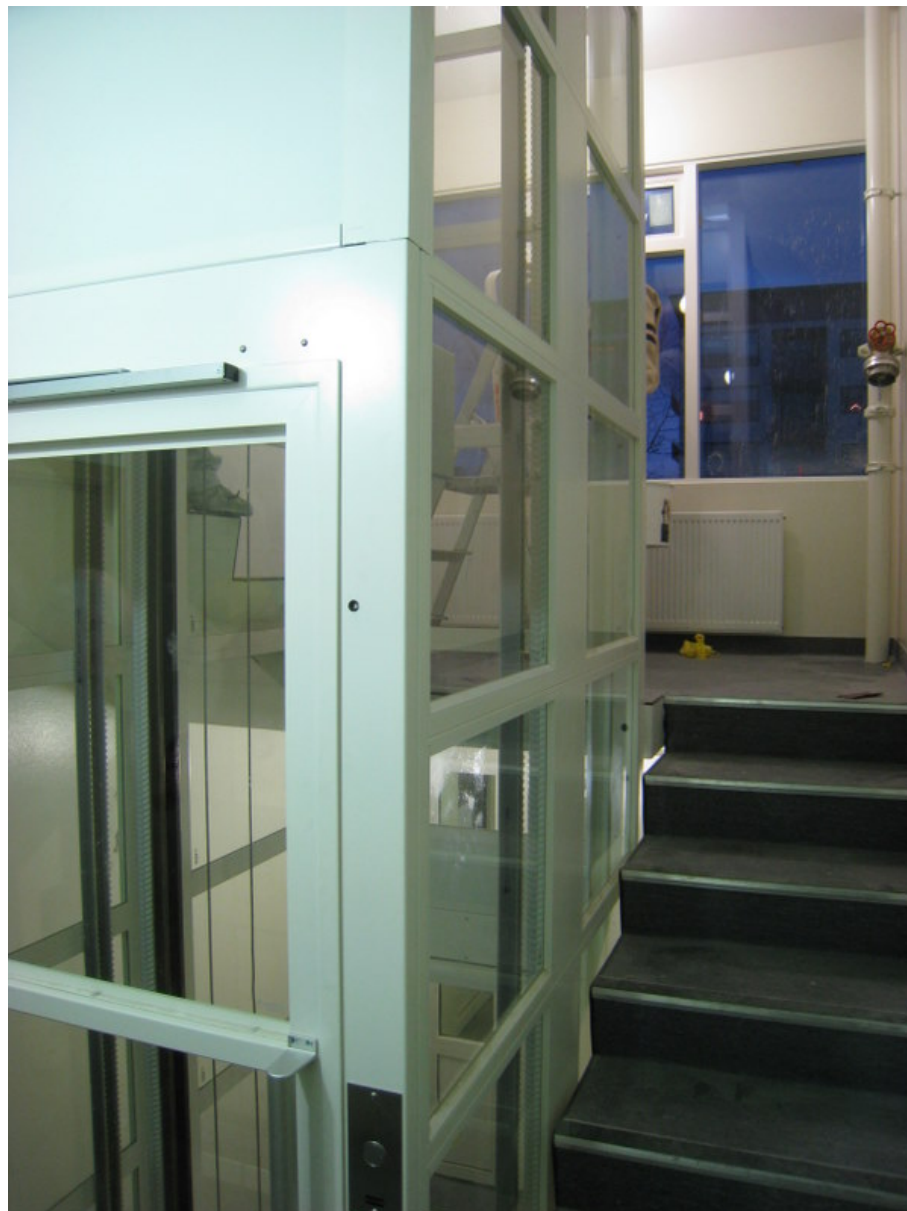
Figure 110. Existing staircase with an elevator built in. Photo: (Björn Marteinsson).

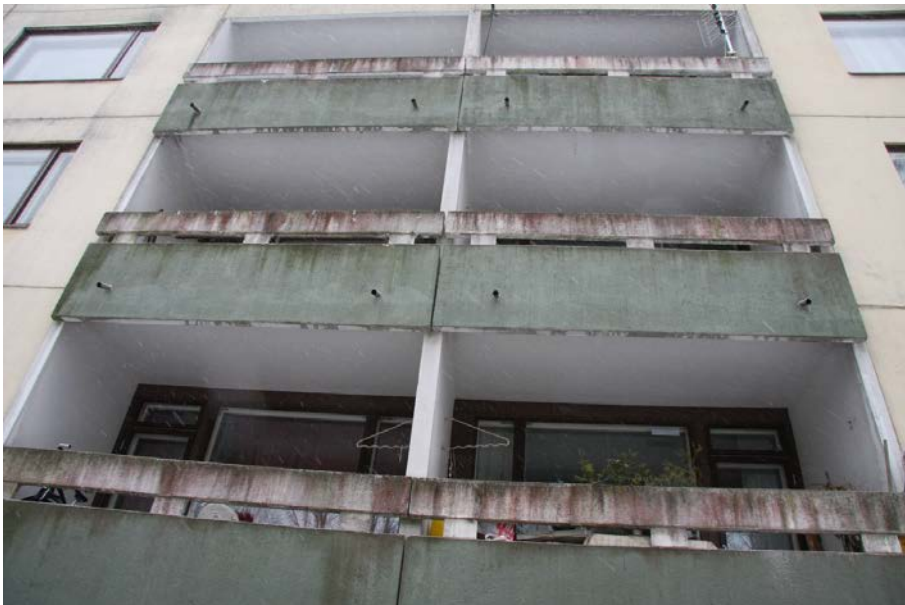
Figure 113. Sahatie 2: balconies in poor condition. Photo: (Pekka Huovila).

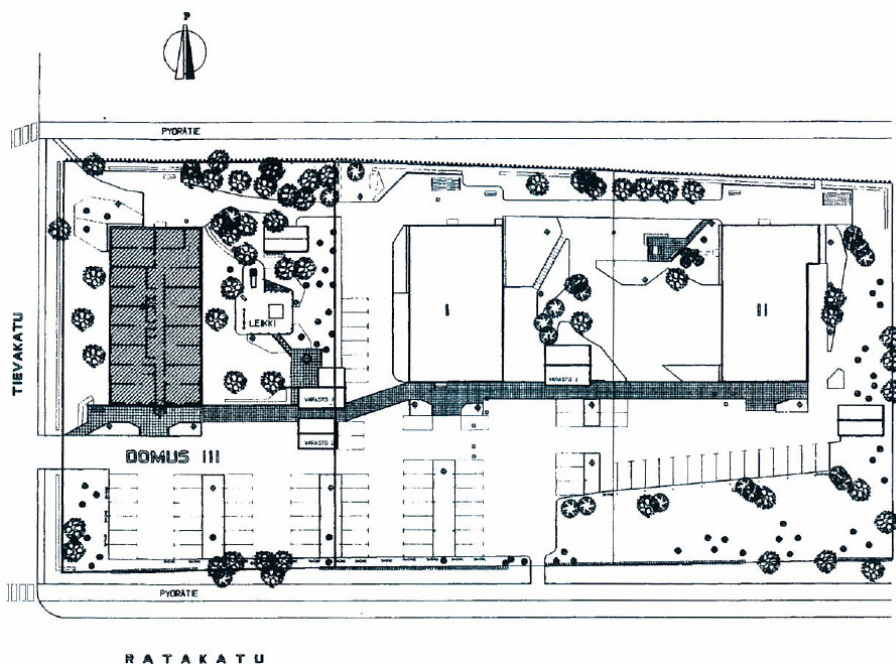
Figure 120. DAS III site plan. The building's gross floor area is 2,443 m² with 46 apartments and total net floor area 1,923 m². Source: (DAS, 2009: 5).

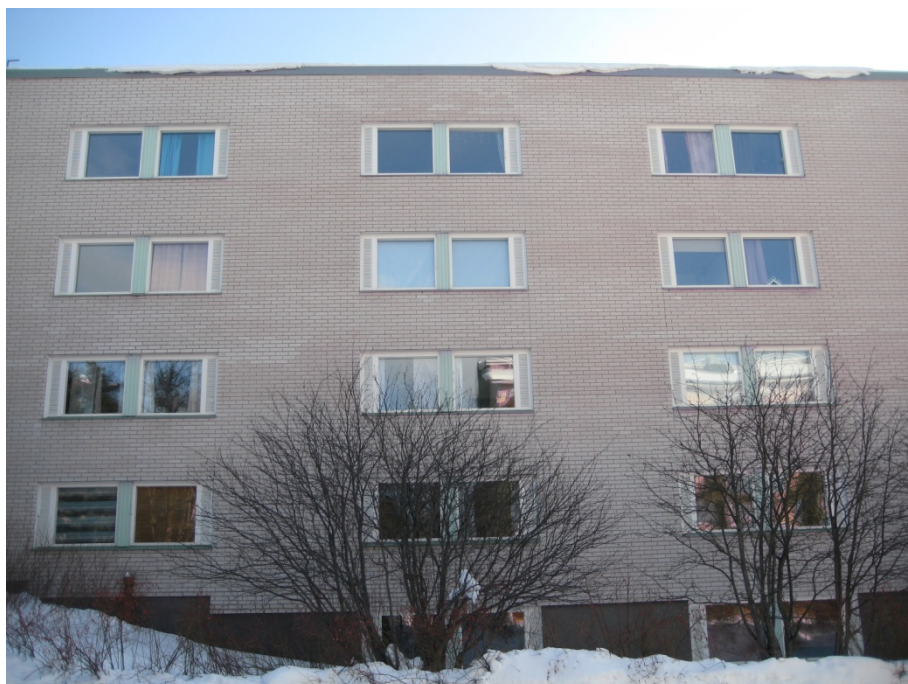
Figure 121. DAS III has a ventilated masonry facade. Photo: (Jyri Nieminen).

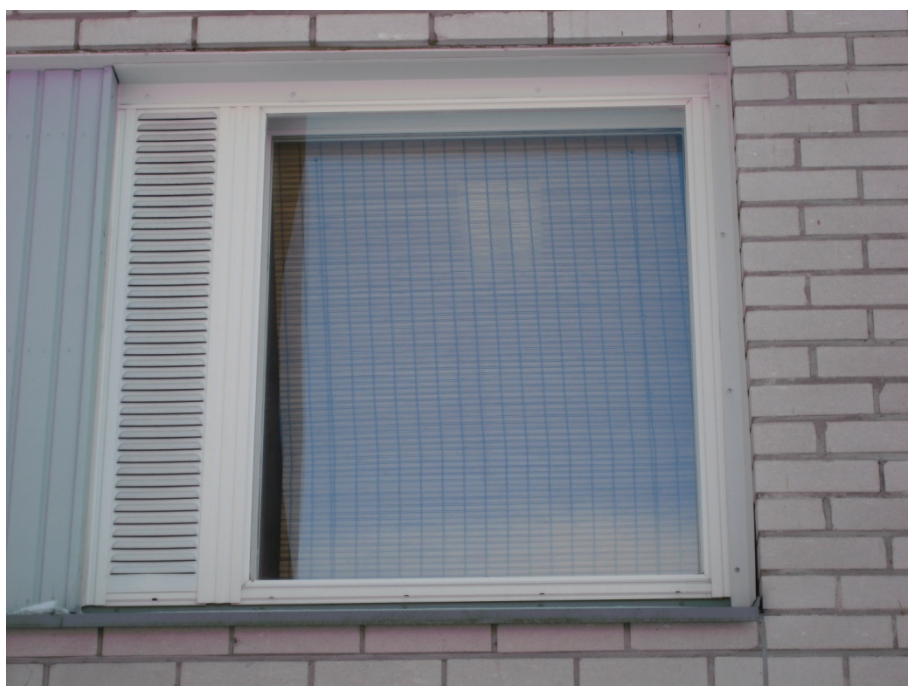
Figure 122. The windows were upgraded in 1995. Photo: (Jyri Nieminen).

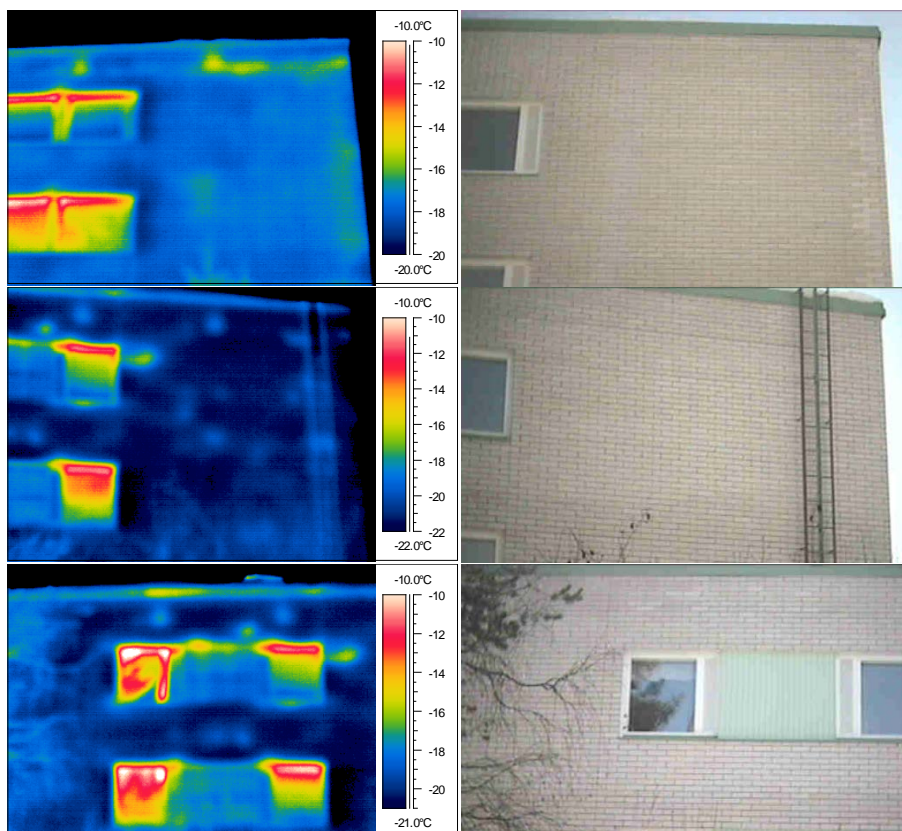
Figure 125. Selected results from thermo-graphic analysis. In general, the survey did not show any major problems with the building. Photos: (Jyri Nieminen).

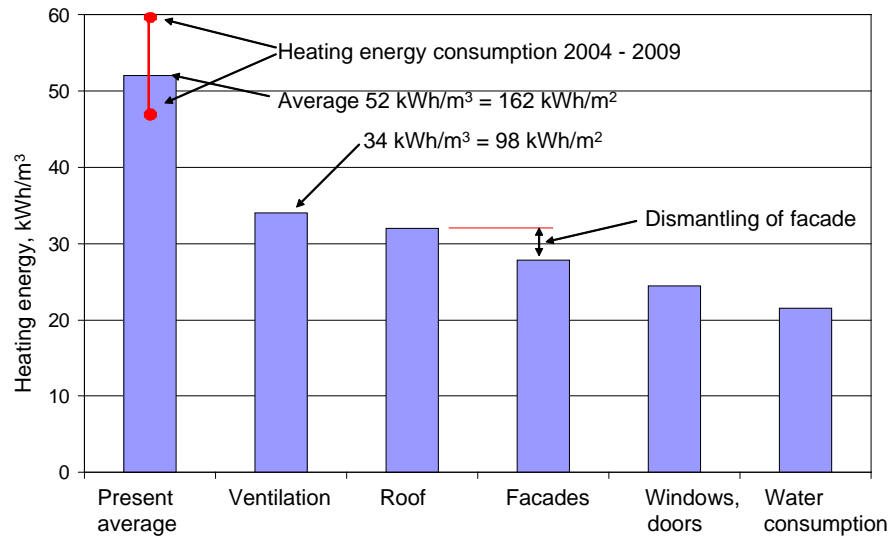
Figure 126. Impacts of energy saving measures in DAS III. Source: (Jyri Nieminen).
