River Restoration Creates Artificial Habitats...or, why you should know the Reference Conditions when Restoring River Hydromorphology

Pedersen, M. L., Friberg, N., & Kronvang, B. (2009). *River Restoration Creates Artificial Habitats...or, why you should know the Reference Conditions when Restoring River Hydromorphology*. Poster presented at Defining Hydromorphological Condition and Links to Ecology, Ballater, Scotland, United Kingdom.

RIVER RESTORATION CREATES ARTIFICIAL HABITATS...OR, WHY YOU SHOULD KNOW THE REFERENCE CONDITIONS WHEN RESTORING RIVER HYDROMORPHOLOGY

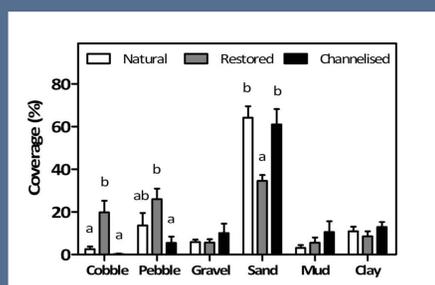
Figure 1. Substrate composition in naturally meandering, channelised and restored streams. Differences in coverage of individual substrates were tested using 1-way ANOVAs and pair wise differences were tested using Bonferroni-corrected post hoc tests. Lower case letters indicate significant differences.

The restored streams clearly had higher proportions of cobble and pebble substrate compared to the natural streams and lower coverage of sand (Fig. 1). The abundance of Ephemeroptera, Plecoptera and Trichoptera (EPT) taxa was significantly lower in channelised reaches, intermediate in natural reaches and highest in restored reaches (Fig 3).

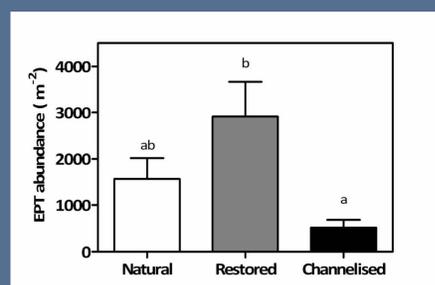
Figure 2. Abundance of EPT taxa in naturally meandering, restored and channelised streams. Differences in EPT abundance were tested using 1-way ANOVA and pair wise differences were tested using Bonferroni-corrected post hoc tests. Lower case letters indicate significant differences.

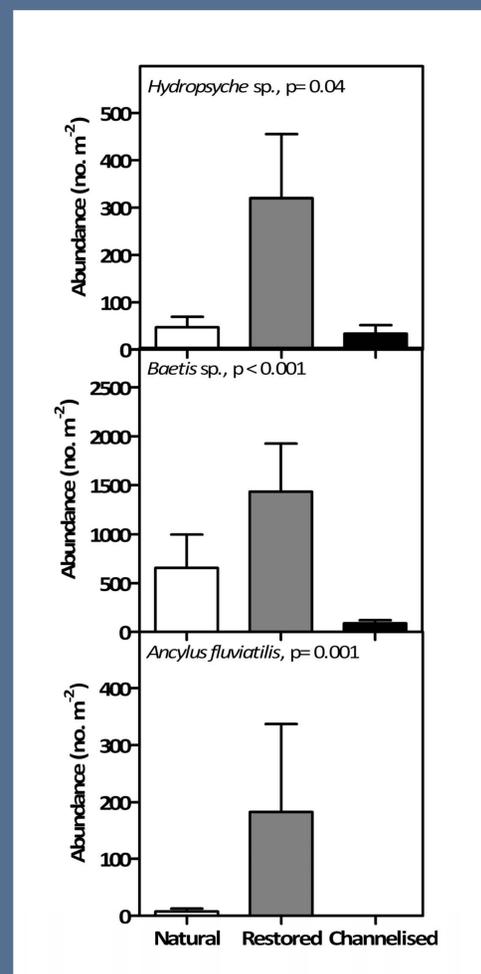
Figure 3. Abundance of three selected macroinvertebrate taxa associated with coarse substrates. Differences in EPT abundance were tested using 1-way ANOVA on log-transformed data.

We analysed abundances of individual taxa in the three stream types. Many taxa showed no systematic or significant difference among the three stream types. Overall macroinvertebrate abundance, taxonomic richness and diversity varied little among the streams. However, several taxa associated with cobble and pebble substrate were clearly favoured by the high coverage of these substrates in the restored reaches (Fig 3). *Ancyclus fluviatilis* and the Ephemeroptera genera, *Baetis* and *Hydropsyche* were found in very high numbers on the re-meandered reaches compared to the natural and channelised reaches.
