CLIMA 2016 - proceedings of the 12th REHVA World Congress

Indoor climate quality after renovation for improved energy efficiency

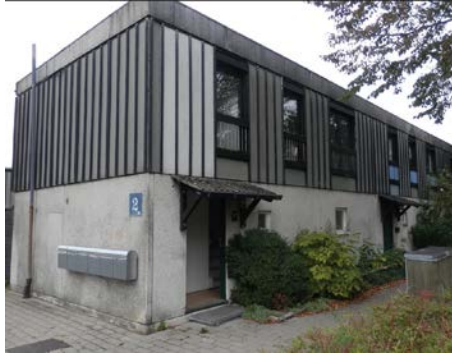
Figure 1. Facade picture of Albetslund Syd before renovation.

Albertslund Syd. Attached houses with two floors erected in 1963-65 including 94 buildings. Typically one building includes 6-7 dwellings of 98 m². The case includes a total of 550 dwellings. The renovation works were very comprehensive. Buildings were torn down with only concrete walls on first floor and foundations remaining and then rebuild according to present standards.

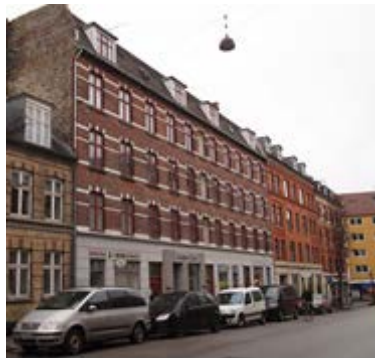
Figure 2. Facade picture of Gl. Jernbanevej before renovation and as of today.

Gl. Jernbanevej. One block of flats with 5 floors erected in 1899 with brick walls. First floor accommodates shops. Other 4 floors have a total of 16 flats on 1139 m² floor area. Flats have an average floor area of 71 m². It is the intention to add one more habitable floor on the roof level and use the generated revenue to finance an extension of the building envelope with added floor area, window area and insulation on the back side of the building. The renovation works was delayed and not initiated while the project was ongoing.

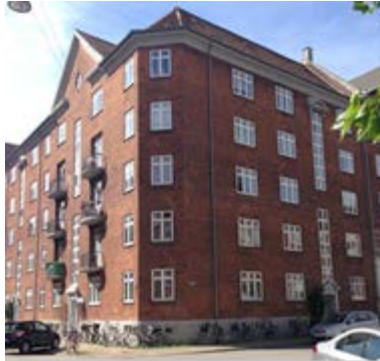
Figure 3. Facade picture of AB Bustrup.

AB Bustrup. One block of flats with 5 floors erected in 1918 with brick walls and a total floor area of 5585 m². The block has 87 flats and the average floor area of one flat is 64 m². The renovation only included exchange of windows and some mounting of new balconies.

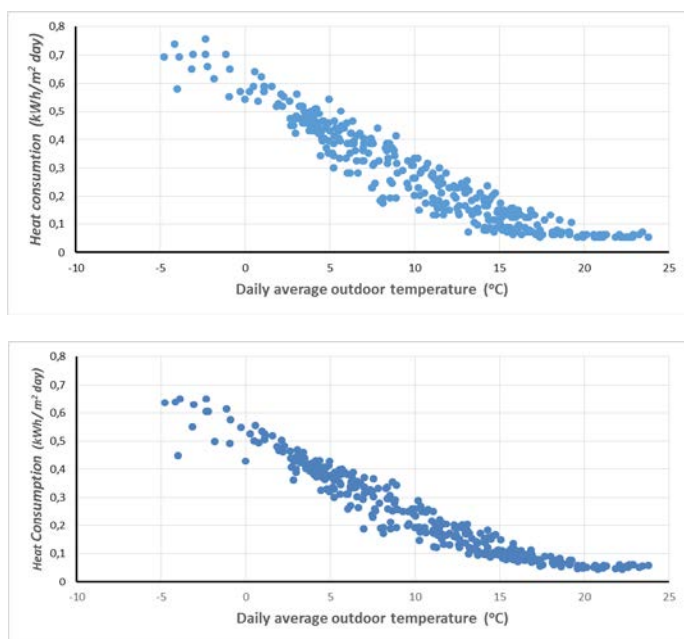
Figure 4. Energy signature or relation between daily average outdoor temperature and heat consumption in first Gl Jernbanevej and then AB Bustrup in the year 2014.

To analyze the reasons further for the differences between calculated and actual heat consumption the energy signatures for the year 2014 in the two cases with detailed information about heat consumption are shown in Figure 4. The two buildings are comparable in insulation standard. It may be

seen that there is a bigger spread of observations and a somewhat steeper increase in heat consumption at lower temperatures in Gl. Jernbanevej than in AB Bustrup. This could indicate less systematic control of supply temperature and possibly increased heat losses from installations at low outdoor temperatures.

For the year 2014 a more detailed analysis of heat consumption was performed at the two cases. The consumption independent of outdoor temperatures (GUF) for distribution losses and heating of hot tap water were quantified as the heat consumption at the best fitted horizontal line to the tail end at outdoor temperatures above 17 °C in Figures 4 and 5. Subtracting this consumption from consumption of all days and finding the average of the remaining consumption gives the heat consumption dependent of outdoor temperatures (GAF). Average outdoor temperature for both locations in 2014 was 9.0 °C. The key energy signature figures may be seen in Table 4.
