CLIMA 2016 - proceedings of the 12th REHVA World Congress

Indoor climate quality after renovation for improved energy efficiency

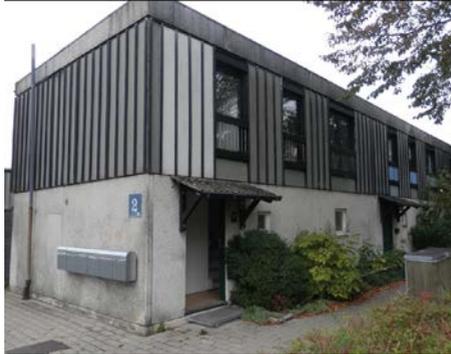
Figure 1. Facade picture of Albetslund Syd before renovation.

Albertslund Syd. Attached houses with two floors erected in 1963-65 including 94 buildings. Typically one building includes 6-7 dwellings of 98 m². The case includes a total of 550 dwellings. The renovation works were very comprehensive. Buildings were torn down with only concrete walls on first floor and foundations remaining and then rebuild according to present standards.

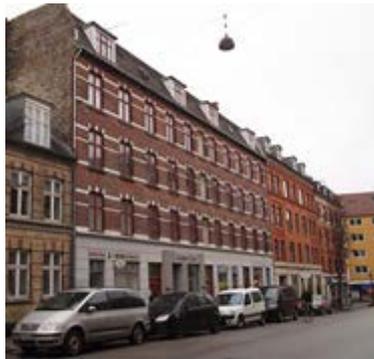
Figure 2. Facade picture of Gl. Jernbanevej before renovation and as of today.

Gl. Jernbanevej. One block of flats with 5 floors erected in 1899 with brick walls. First floor accommodates shops. Other 4 floors have a total of 16 flats on 1139 m² floor area. Flats have an average floor area of 71 m². It is the intention to add one more habitable floor on the roof level and use the generated revenue to finance an extension of the building envelope with added floor area, window area and insulation on the back side of the building. The renovation works was delayed and not initiated while the project was ongoing.

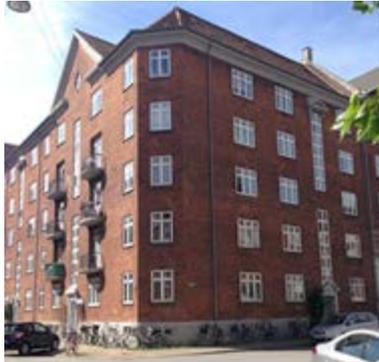
Figure 3. Facade picture of AB Bustrup.

AB Bustrup. One block of flats with 5 floors erected in 1918 with brick walls and a total floor area of 5585 m². The block has 87 flats and the average floor area of one flat is 64 m². The renovation only included exchange of windows and some mounting of new balconies.
