## **Documentation of the performance gap**

# Documentation of the performance gap

Søren Østergaard Jensen, Danish Technological Institute

Kim Wittchen and Jørgen Rose, Danish Buildings Research Institute

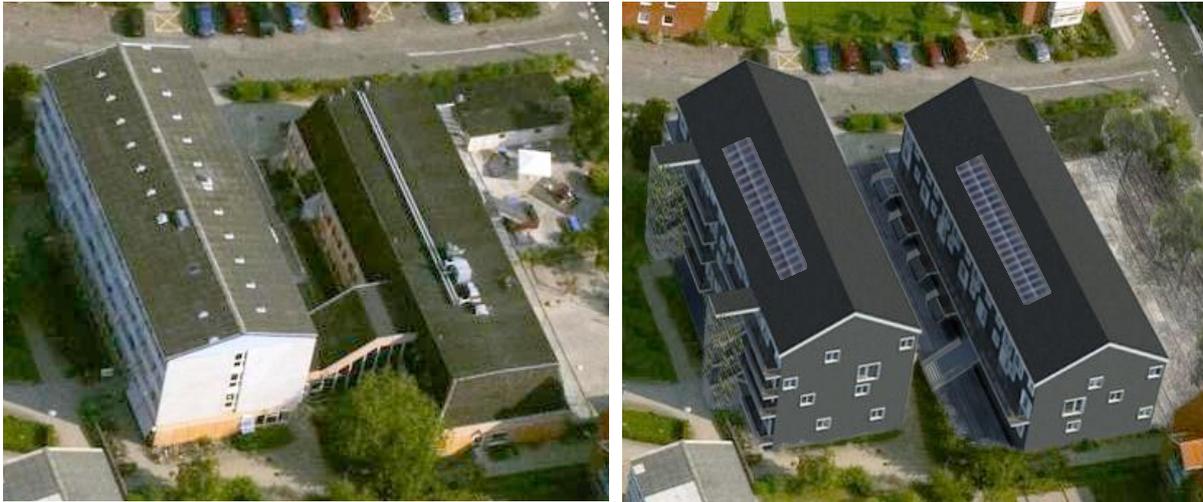
Sems Have was originally constructed in 1970-72 under the name “House of youth”. The two buildings were a four-story building with a dormitory at the first to fourth floor, and an activity centre for school-children at the ground floor. The other building contained a day-care centre for small children at the ground floor and two smaller concert halls at the first floor. In 2011 the buildings were totally worn down and the housing association had to decide if the buildings should be demolished or refurbished. Based on economical calculations it was decided to refurbish the buildings and turn them into 30 modern low energy apartments. Figure 1 shows the buildings before and after the renovation.

Figure 1. Sems Have/House of youth before (left) and after (right) the renovation. Not only the interior but also the exterior went through a major renovation.

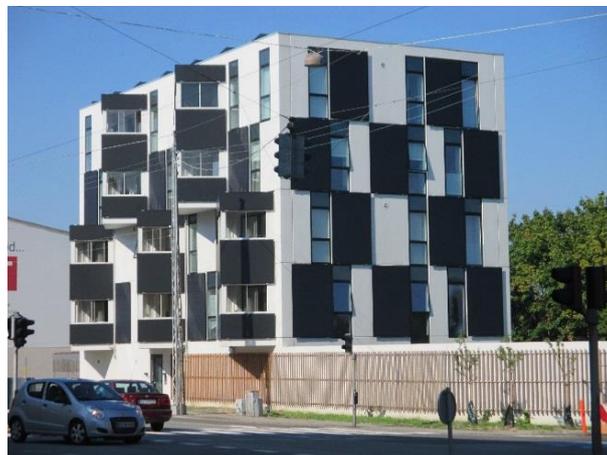
BOLIG+ is a new building with 10 low energy apartments. In addition to being energy-neutral, the building should comply with the Building Class 2020 without any subtraction of electricity produced at the building. Figure 2 shows BOLIG+. The black areas on the facades are different angled PV panels. The roof is also covered with PV panels.

Figure 2. BOLIG+ seen from the street.

Was the building energy neutral with all the PV panels on the facades and roof? Well, the PV panels produce 26 % less than expected and the occupants used a bit more electricity in the apartments, so the building was not energy neutral. However, if the PV panels had produced as designed, and the electricity use in the apartments was as defined in the design phase, the building would only be 11 % from being energy neutral, which is actually a very good result.
